Repairs to concrete fuel store floor

Application: FPA-Floor Problem Areas

Substrate: Concrete

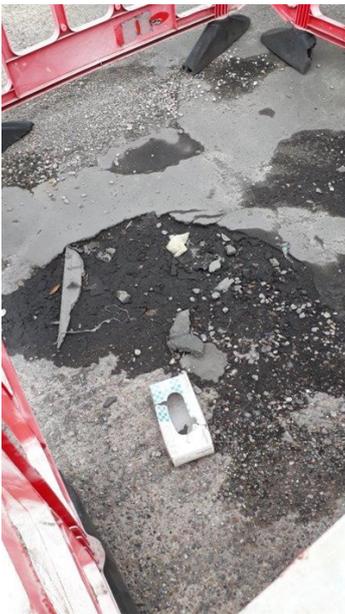
Repeat impact from the dropping of Oxygen cylinders, along with heavy lorry wear and tear had broken up large areas of the fuel store at a large distribution center

Broken floor with large holes and cracks due to impact

The Belzona application was carried out in one day and was returned to service the following day after that, giving a turnaround of just 2 days. The alternative would have taken much longer and also necessitated the saw-cutting and breaking out to cast new concrete, which would then have had to be left for a number of weeks to fully set

Break out loose and friable materials and vacuum
 Apply Belzona 4911 to all target areas
 Mix and apply 4151 resins and 4111 aggregates
 Trowel off to compress and leave to cure

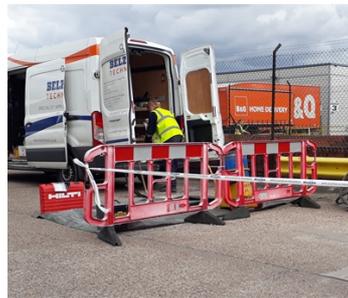
Works taking place to repair the damage

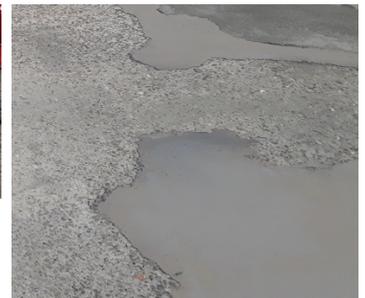
Works completed

6 years on

ongoing operations of the distribution warehouse.
6 years on, the repairs are still performing as intended
