# BELZONA REFITS CRUSHER BEARING

ID: 995

Industry: Mining & Quarrying  
Application: MPT-Mechanical Power Transmission

Customer Location: Limestone quarry, Silex, MO  
Application Date: Summer 1996

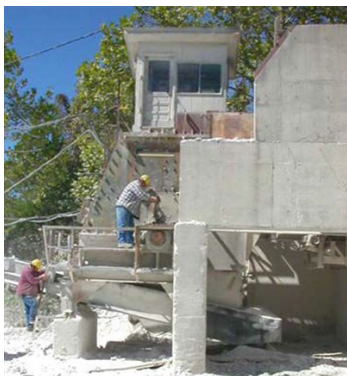
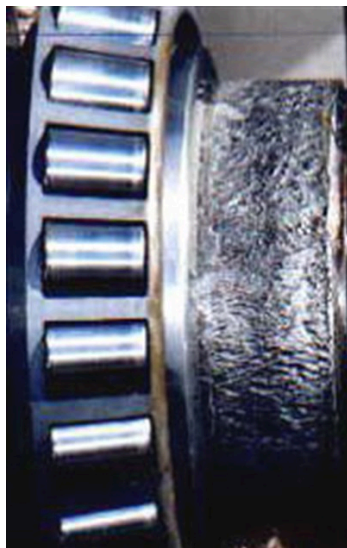
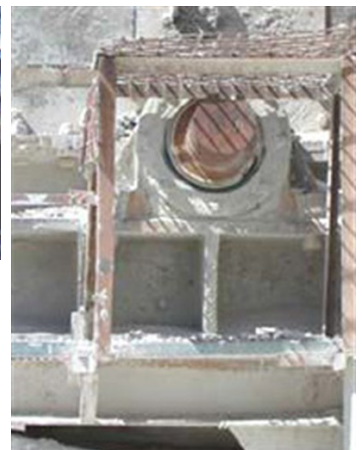
Perfect fit required onto rough shaft to avoid premature failure. Previous repair with "competitor" failed.

\* Overall view of the crusher Damaged journal Belzona® 1111 applied on the journal Finished bearing refit ,

New 12" dia. bearing had to be fitted to worn shaft on crusher

Application carried out in accordance with the Belzona Know-How System Leaflet MPT-7. The bearing was heated to 250°F. Belzona® 1111 was applied around the journal and the hot bearing quickly slid into place.

The alternative was at least a 30 day (and lost production) wait for a new shaft during the peak season. Follow up in February 2008, the repair is still holding up.
