BELZONA REFITS CRUSHER BEARING

ID: 995

Industry: *Mining & Quarrying*
Application: *MPT-Mechanical Power Transmission*

Customer Location: *Limestone quarry, Silex, MO*
Application Date: *Summer 1996*

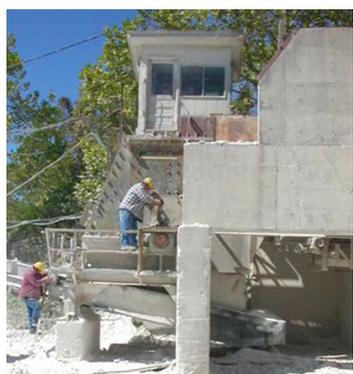
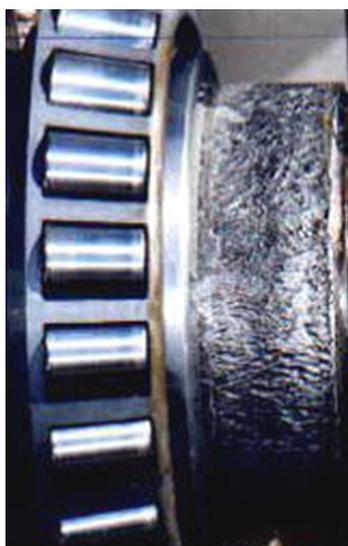
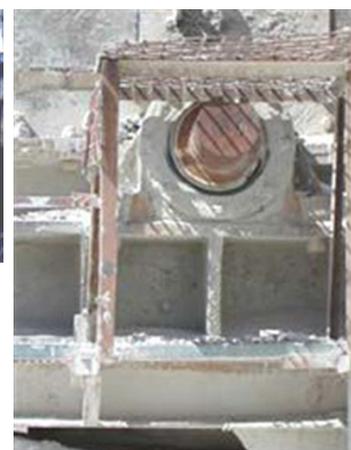
Photograph Descriptions

Perfect fit required onto rough shaft to avoid premature failure. Previous repair with "competitor" failed.

* Overall view of the crusher Damaged journal Belzona® 1111 applied on the journal Finished bearing refit ,

New 12" dia. bearing had to be fitted to worn shaft on crusher

Application carried out in accordance with the Belzona Know-How System Leaflet MPT-7. The bearing was heated to 250°F. Belzona® 1111 was applied around the journal and the hot bearing quickly slid into place.
