BELZONA REFITS CRUSHER BEARING

ID: 995

Industry: Mining & Quarrying
Application: MPT-Mechanical Power Transmission

Customer Location: Limestone quarry, Silex, MO
Application Date: Summer 1996

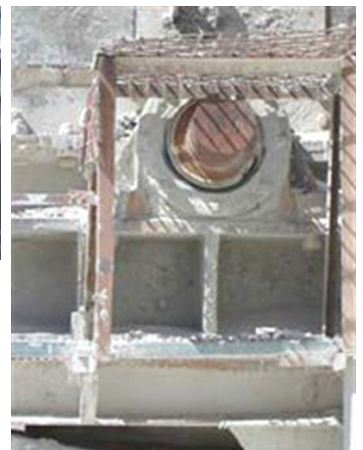
Photograph Descriptions

* Overall view of the crusher Damaged journal Belzona® 1111 applied on the journal Finished bearing refit ,

New 12" dia. bearing had to be fitted to worn shaft on crusher

Application carried out in accordance with the Belzona Know-How System Leaflet MPT-7. The bearing was heated to 250°F. Belzona® 1111 was applied around the journal and the hot bearing quickly slid into place.
