Loading bay concrete repair

ID: 9950

Application: *WPA-Wall Problem Areas*

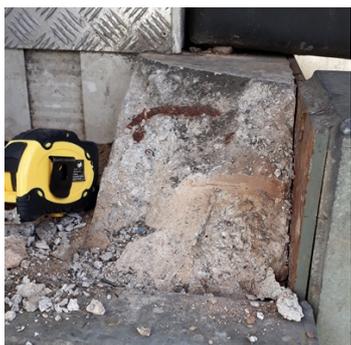
Constant lorry impacts had damaged a loading bay side wall

Damage to loading bay side wall

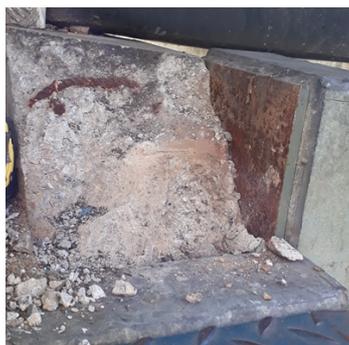
Showing a large repair needed

Remove all loose materials and vacuum

Mix and apply Belzona 4911 TX Conditioner

Create former and apply Belzona 9411 release agent to internal surfaces

Mix and apply Belzona 4111 and trowel off

Allow to cure and remove released woodwork

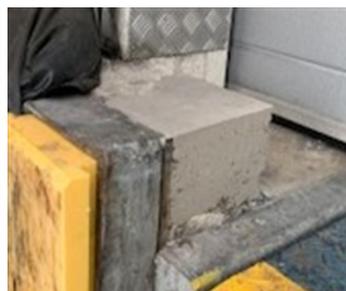
Repair completed

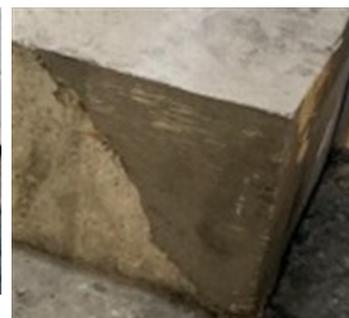
Repair some 5 years later showing scratched from lorries, but no real damage

To recast concrete to this area would have been unsuccessful. The client needed a quick turnaround and an extreme durable product that would at least outlast concrete. 5 years on and the repair is still performing as expected, with a few scratch marks showing it's durability to heavy impact
