# Belzona solution for failed expansion joints

ID: 9951

Industry: *Buildings & Structures*  
Application: *FPA-Floor Problem Areas*  
Substrate: *Concrete*  
Products: *Belzona 4521 (Magma-Flex Fluid), Belzona 4911 (Magma TX Conditioner)*

Customer Location: *Worksop*  
Application Date: *April 2019*

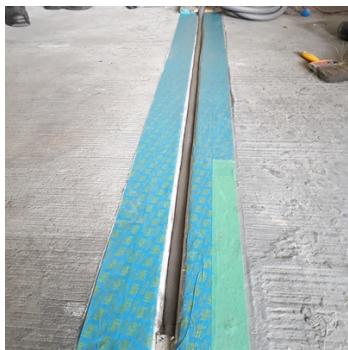
Area is prepared and foam backer rod is placed at the correct depth

All target areas were cleaned and vacuumed, then masked along the sides to give clean lines

A foam backer rod was inset into the joint at a depth of half that of the joint's width

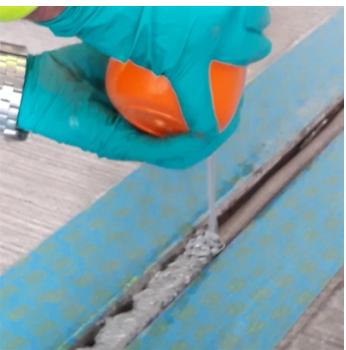
Joint prepared and 4521 being applied

Belzona 4911 was applied to all target areas

The Belzona 4521 was mixed and applied in accordance with the IFU

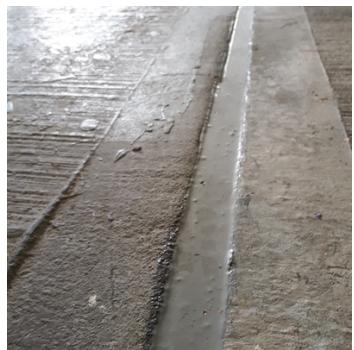
Completed works showing the Belzona 4521 still in it's intended location

The Belzona 4521 held it's place, giving it ample time to cure, giving a long lasting and robust solution
