Valley gutter joint repairs

ID: 9952

Application: RPA-Roof Problem Areas

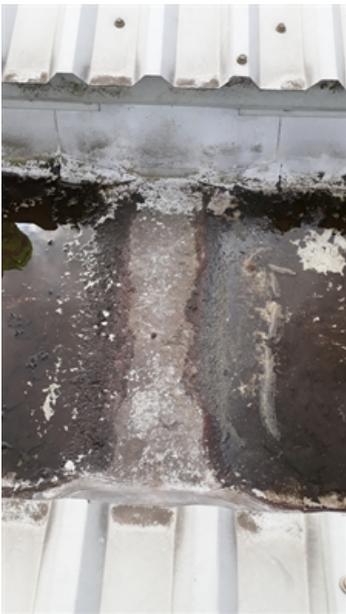
Areas of probable leaks were identified on external inspection of the high bay

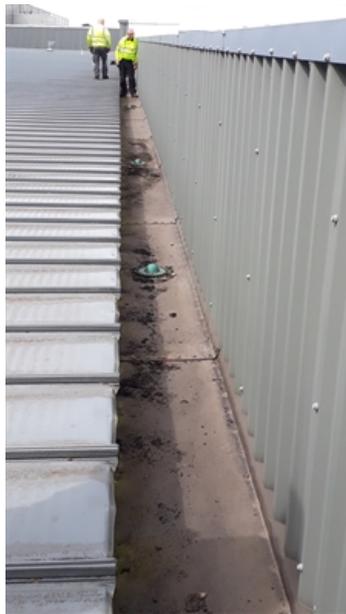
All joints were identified and marked on an aerial plan

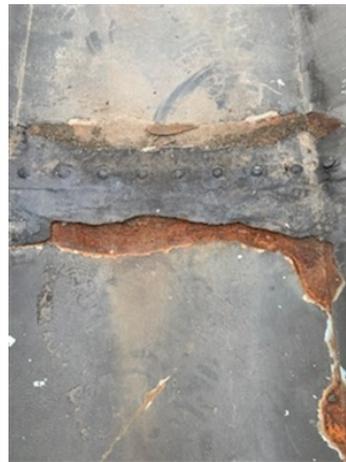
Obvious issues were showing and Belzona was the chosen solution

All old materials were removed

The area was wire brushed, cleaned and degreased using Belzona 9111

A first coat of Belzona 3121 was applied and the Belzona 9331 reinforcing sheet laid in

A second coat of Belzona 3121 was applied to complete the repair

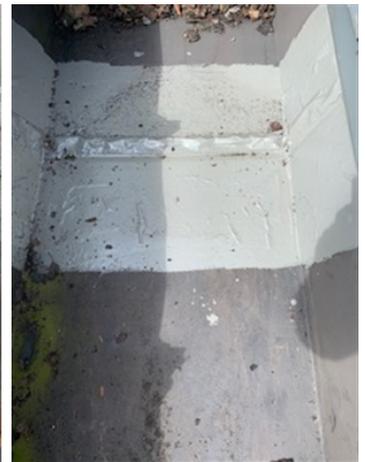
6 years on and the repairs to the valley gutter joints continue to protect.
