Dyno Mill Wear Ring Repair

ID: 9954

Industry: Chemical & Petrochemical
Application: FBC-Fans, Blowers and Compressors

Substrate: Stainless-steel

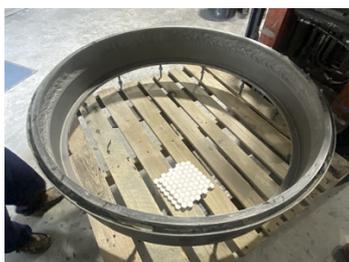
The internal diameter of a 40" Dyno Mill wear ring exhibited significant wear and erosion in multiple sections. The high abrasion environment within the mill caused degradation, compromising performance and longevity. A long-term, abrasion-resistant solution was required to restore integrity and extend service life.

Before Application

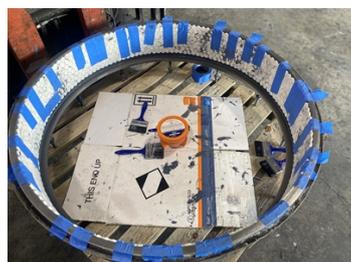
Applying Belzona 9811 alumina tiles

Once cured, the entire wear ring ID was overlaid with Belzona 9811/1812 alumina ceramic hex tile system for maximum abrasion protection.

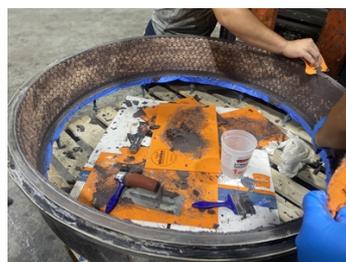
Belzona 1812 Grout

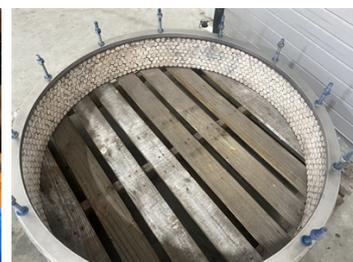
Finished application

Final inspection and demobilization followed after cure and QA.
