# Belzona system repairs areas to wet pulp screw conveyor

Application: SHM-Solids Handling Machinery

Customer Location: Kings Lynn

Products: Belzona 1311 (Ceramic R-Metal), Belzona 1391T

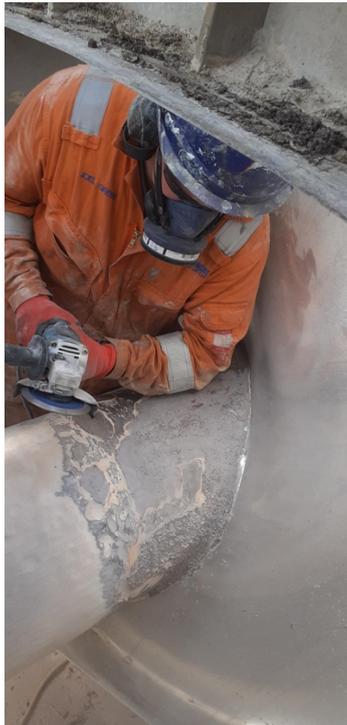
A Wet Pulp Screw Conveyor with localised areas of erosion and scoring. These defects were causing process issues and preventing the conveyor from operating at its optimum capacity.

wet pulp screw conveyor with localised areas of erosion and scoring

The affected areas are prepared to minimum surface profile using hand tools

Surface is rebuilt using Belzona 1311 (Ceramic R-Metal) and reinforcement sheet

Two coats of Belzona 1391T adds protection to the screw conveyor

The three areas of concern are located on the shaft only, affecting three separate sections between the screw flights. The customer requested

To limit disruption, the application areas were prepared using power tools only, in accordance with SSPC-SP11.

Once prepared, the areas will be thoroughly cleaned. Any sections showing loss of profile were rebuilt back to standard using Belzona. Following this, the full circumferential repair areas were reinforced using Belzona 1311 and Belzona 9341 then be left to stabilise overnight.

The following morning, the repaired areas were inspected and then received two coats of Belzona 1391T.
