# BELZONA PROTECTS CITIES WATER PUMPS

Application: CEP-Centrifugal Pumps

Customer Location: City of Hannibal, MO

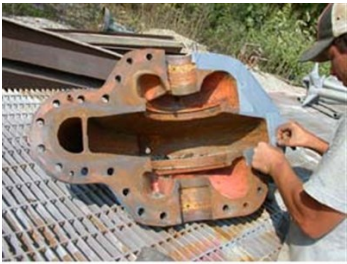
*Failure due to high cavitation caused by bad suction conditions that could not be changed.*

- \* Lower casing half before application ,
- \* Lower casing half, completed ,
- \* Impeller with casing ring shimmed and ready to refit the casing ring seats ,
- \* Rotor set in lower casing half, ready to install the top casing ,

Application carried out in accordance with Belzona Know-How System Leaflets CEP-3 and CEP-5.
