BELZONA PROTECTS CITIES WATER PUMPS

Application: CEP-Centrifugal Pumps

Customer Location: City of Hannibal, MO

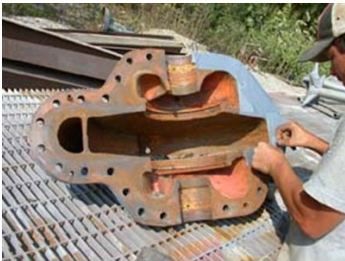
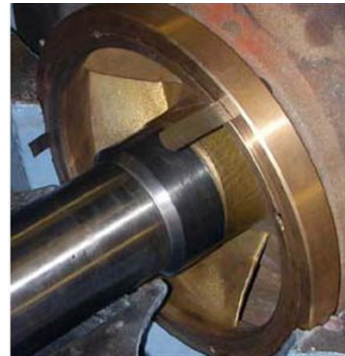
Photograph Descriptions

Failure due to high cavitation caused by bad suction conditions that could not be changed.

- * Lower casing half before application ,
- * Lower casing half, completed ,
- * Impeller with casing ring shimmed and ready to refit the casing ring seats ,
- * Rotor set in lower casing half, ready to install the top casing ,

Application carried out in accordance with Belzona Know-How System Leaflets CEP-3 and CEP-5.

Slightly over a days work and under \$2,000 of Belzona, the first pump was returned to service. A follow up was done in January 2008 and revealed this pump as well as others done subsequent to this one were still running like new.
