# Belzona SF6-FIX on a Voltage Transformer in the Potash Industry

ID: 9962

**Industry:** Mining & Quarrying  
**Application:** GSS-Gaskets, Seals and Shims  
**Substrate:** Carbon steel  
**Products:** Belzona 1981 (SuperWrap II), Belzona 7311

**Customer Location:** Saskatchewan  
**Application Date:** July 2025

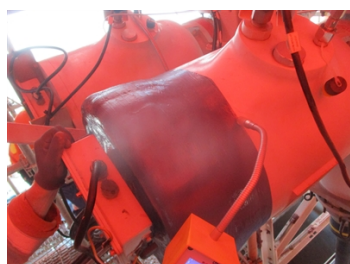
Completed SF6-FIX application with final layer of Belzona 7311

The bond areas were grit blasted, and a breather tube and breather membrane were installed over the flange to channel any leaking gas away from the repair area, preventing defects while the material cured.

The first layer of Belzona 7311 was applied, with 9341 reinforcement mesh placed over the flange area and extending onto the bond area. Belzona 1981 resin and 9371 glass fiber reinforcement tape were then applied in five layers over the flange area and onto the bond area.

Once cured, the surface was prepared to a frosted appearance, and the final layer of Belzona 7311 was applied. After curing to the full service level specified in the IFU, the system was brought back online. SF6 leak testing was conducted, and no leaks were detected.
