Belzona is Keeping the Port Cranes Corrosion Free

ID: 9963

Industry: *Transport*
Application: *SOS-Ships and Offshore Structures*

Substrate: *Carbon steel*
Products: *Belzona 1121 (Super XL-Metal)*

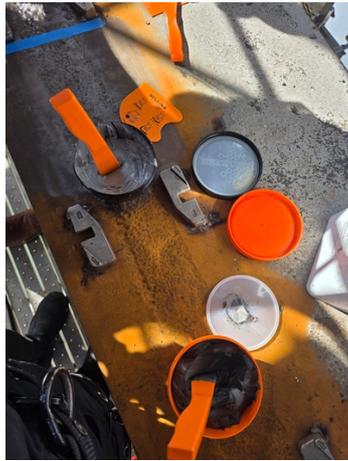
The trolley rail bed flanges have been corroding due to the aggressive environment and ponding rainwater. The inevitable pitting was affecting the functioning of the cranes.

Condition of the rail bed flange before surface preparation

All metal surfaces were grit-blasted to SSPC-SP10 several days prior to the application. During application days, the same metal surfaces were prepared with power tools and cleaned/degreased with a solvent rich cleaner.

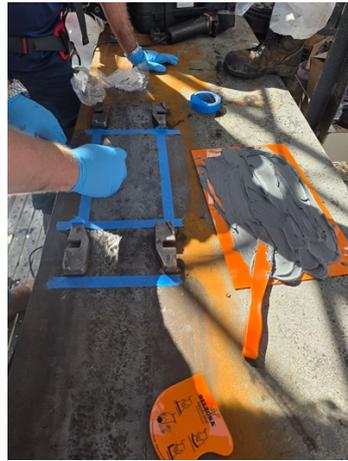
Belzona 1121 being applied

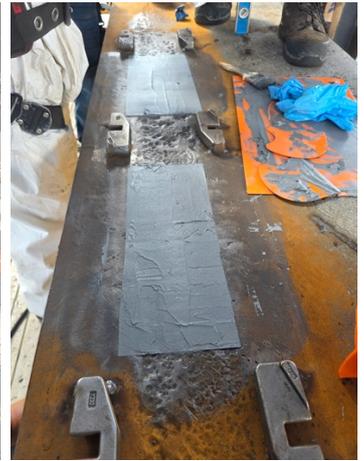
Application of Belzona 1121 completed in two sections
