# Belzona is Keeping the Port Cranes Corrosion Free

ID: 9963

Industry: *Transport*  
Application: *SOS-Ships and Offshore Structures*

Substrate: *Carbon steel*  
Products: *Belzona 1121 (Super XL-Metal)*

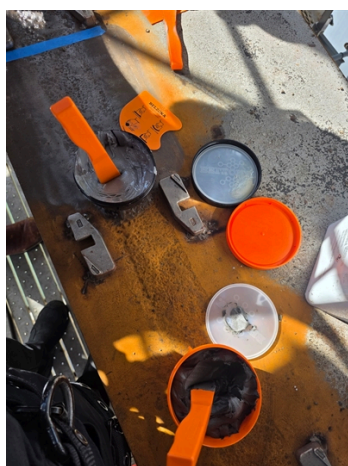
*The trolley rail bed flanges have been corroding due to the aggressive environment and ponding rainwater. The inevitable pitting was affecting the functioning of the cranes.*

Condition of the rail bed flange before surface preparation

All metal surfaces were grit-blasted to SSPC-SP10 several days prior to the application. During application days, the same metal surfaces were prepared with power tools and cleaned/degreased with a solvent rich cleaner.

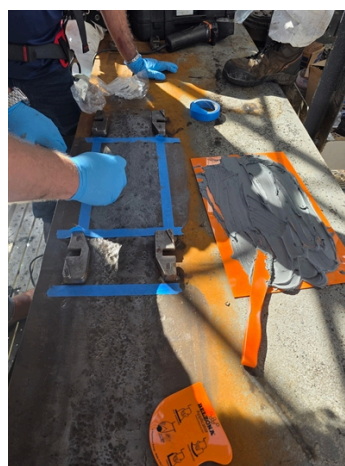
Belzona 1121 being applied

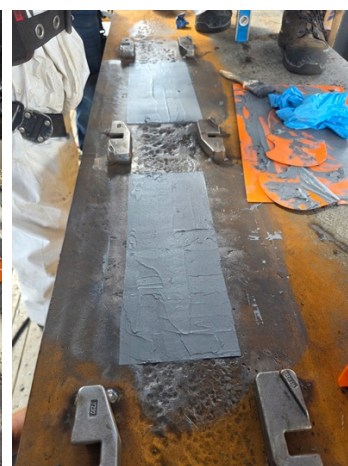
Application of Belzona 1121 completed in two sections
