Expansion Joint Repair

ID: 9965

Industry:	Pharmaceutical	Customer Location:	Kryoneri Greece
Application:	FPA-Floor Problem Areas	Application Date:	July 2024
Substrate:	Concrete		
Products:	Belzona 2221 (MP Fluid Elastomer),Belzona 2911 (Elastomer QD Conditioner),Belzona 4111 (Magma-Quartz),Belzona 4911 (Magma TX Conditioner),Belzona 9411 (Release Agent)

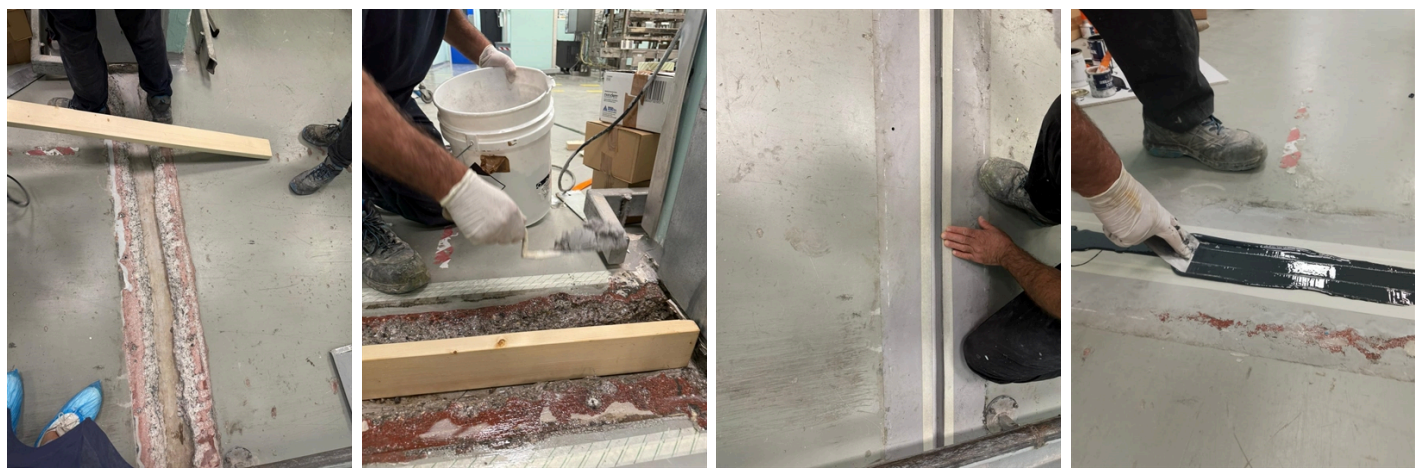
The expansion joint exhibited advanced deterioration, resulting in loss of movement accommodation and ineffective water sealing. This condition increased the risk of progressive substrate degradation and contributed to vehicle impact damage, including premature tire and suspension wear.

Initial surface condition

Belzona 4111 application

Belzona joint edge repair completed

Application completed

The Belzona system allowed in-situ repair without shutdown, avoiding production losses and costly traffic rerouting. Rapid curing enabled a quick return to service, minimising disruption and labour costs. Its long-term durability reduces future maintenance, protecting both the substrate and vehicles, delivering significant lifetime savings.

The application was carried out in accordance with FPA-5 and FPA-6.
