# Floor Coating and Protection in Chemical Tank Farm with Belzona 4311

ID: 9967

Application: FPA-Floor Problem Areas

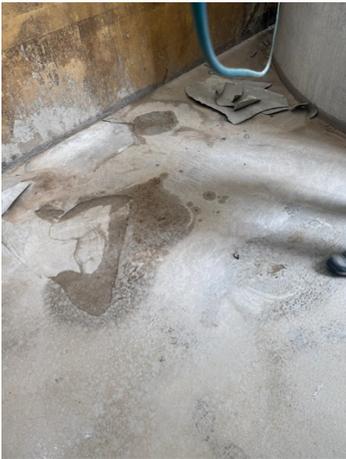
The tank farm floor, exposed to sodium hypochlorite (bleach), had suffered severe chemical attack. The old coating had lifted and peeled away, leaving bare, porous concrete that absorbed spills, was hard to clean, and offered no protection against further damage.

Failed previous coating

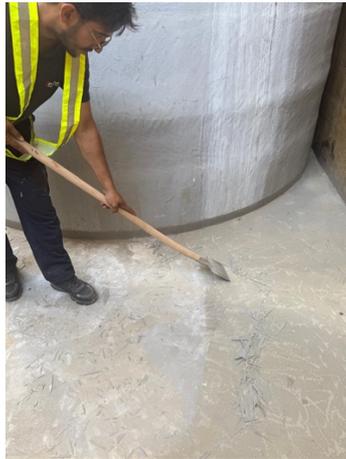
Surface preparation

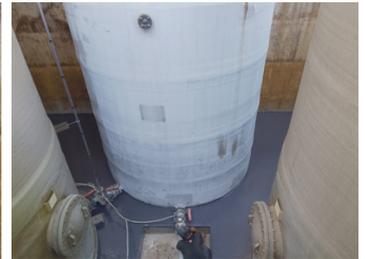
Application Completed

The application was carried out in accordance with FPA - 3
