SF-6 leak sealing on bushings

ID: 9973

Industry: Power
Application: VPF-Valves, Pipes and Fittings
Substrate: Aluminum
Products: Belzona 7311

Customer Location: United Kingdom
Application Date: August 2025

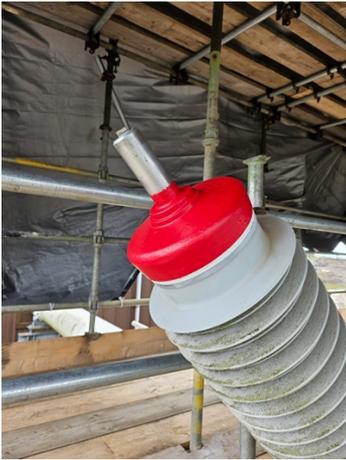
A bushing was found to be leaking SF-6 gas. A seal was required to stop this leak.

Existing coating this was removed & the surface prepared.

The existing coating was removed & the surface prepared. Belzona 7311 was then built up with layers of Belzona 9341 reinforcement sheet.

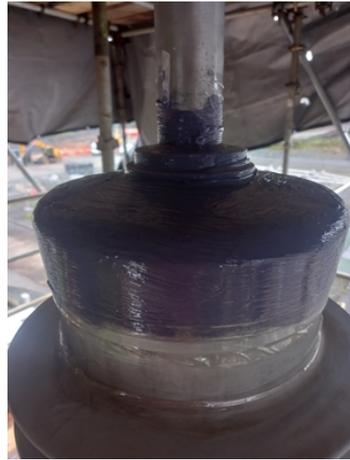
Wetting out substrate.

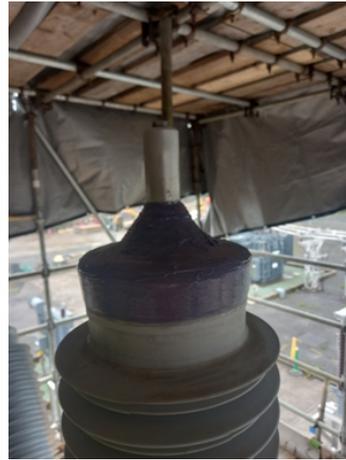
Belzona 7311 built up & Belzona 9341 reinforcement added.

The repair was completed in a few hours & cured in 2 days prior to re-gassing & service.
