# Pump Base Repair & Coating with Belzona

ID: 9974

**Industry:** Chemical & Petrochemical  
**Application:** TCC-Tanks and Chemical Containment Areas  
**Substrate:** Concrete  
**Products:** Belzona 4111 (Magma-Quartz), Belzona 5821

**Customer Location:** Decatur, AL  
**Application Date:** July 2025

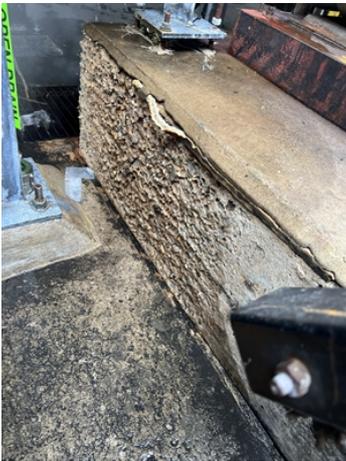
The concrete pump base had water running over it for several years due to constant water running over the pump to keep it from over heating. The water had been eroding the concrete for many years. They were facing the replacement of two pump bases.

Before Belzona concrete repair and coating picture

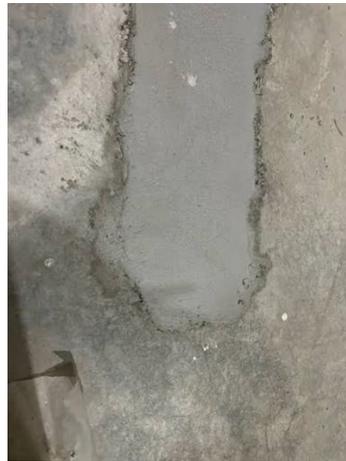
Repaired crack area on side of pump base using Belzona 4111

We used needle guns to prepare the surface area. Once the surface was prepared we then cleaned the concrete using a vacuum to remove dust and small debris and MEK to clean the surface.

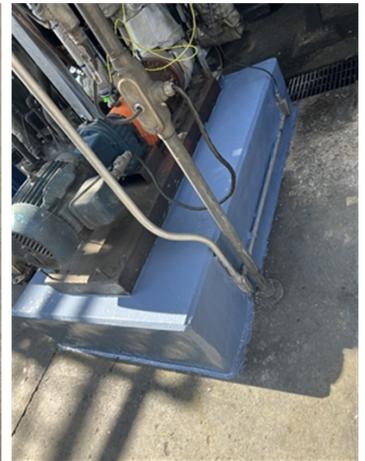
Completed repair and coating of concrete pump base using Belzona 4111 and Belzona 5821
