Belzona repairs Bronze Impeller

ID: 9975

Application: *SHM-Solids Handling Machinery*

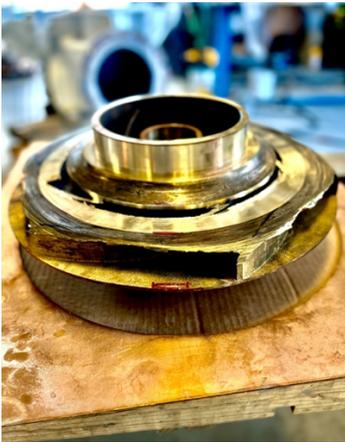
The customer was facing shutdown in their facility due to not having a backup impeller and long lead time for a new impeller.

Before Belzona repair and protective coating

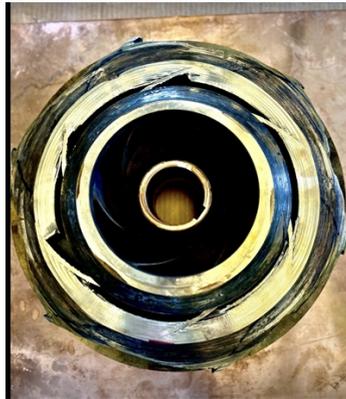
Cutting it down to make it better

We used a local machine shop to cut down the impeller about 1/8 inch. We then cold bond plated a new 1/8 inch bronze plate on to the impeller using Belzona 1111. Once we smoothed out the surface area and tying in the plate to the base metal we then applied Belzona 1321.

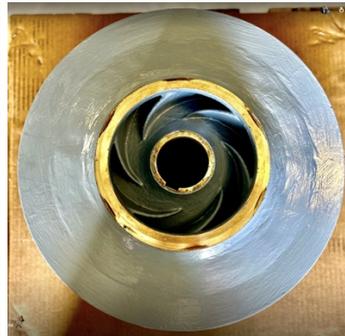
Top view of the repair using Belzona 1111 and brass plate

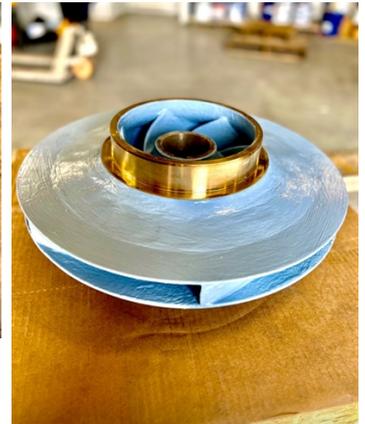
Completed repair of brass impeller using Belzona 1111 and Belzona 1321
