# Rubber Flange Repair with Belzona 2111

ID: 9976

Industry: *Chemical & Petrochemical* Customer Location: *Decatur, AL*  
 Application: *VPF-Valves, Pipes and Fittings* Application Date: *October 2023*  
 Substrate: *Carbon steel*  
 Products: *Belzona 2111 (D & A Hi-Build Elastomer), Belzona 2911 (Elastomer QD Conditioner)*

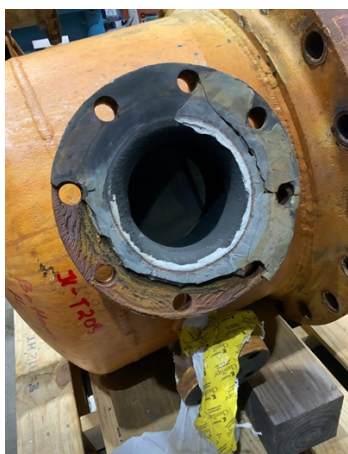
The customer was in outage and discovered the rubber lining of the condenser head was deteriorated and could not go back in to service.

Before Belzona 2111 repair

We removed the current rubber lining of the flange face us in a chisel hammer followed by grit blasting the surface to SSPC-SP 10 specifications.

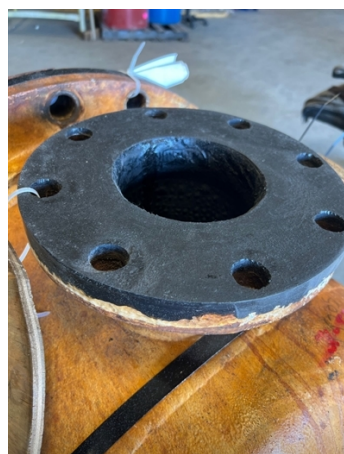
The next day we removed the shim stock to reveal the completion of the Belzona 2111 repair to the flange.
