# Belzona 3111 flexible membrane saves roof at North Dakota Mine

**Industry:** Buildings & Structures  
**Application:** RPA-Roof Problem Areas  
**Substrate:** Aluminum  
**Products:** Belzona 3111 (Flexible Membrane), Belzona 3921 (GSC Surface Conditioner), Accessories, Spray Instructions

**Customer Location:** Beulah, North Dakota  
**Application Date:**

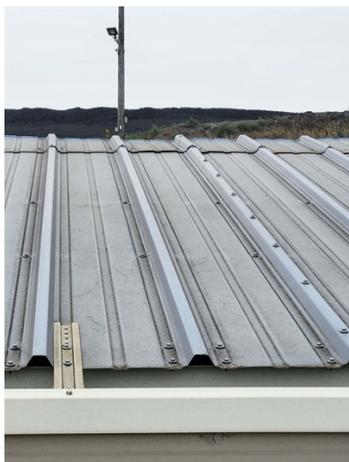
Roof area approximately 3500 sq ft had rust over 50% and very small holes and the seams were severely leaking. Building overhang out at unloading area at Mine.

Picture of roof before starting application

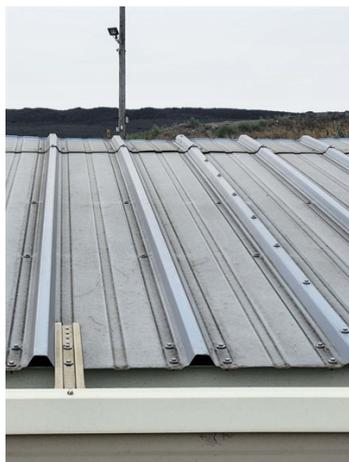
Prior to application of Belzona 3111

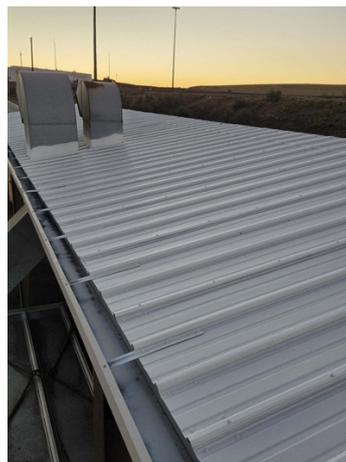
Belzona 3111 applied on 100% of roof with mesh installed on all seams fully reinforced.

The client was looking at a new roof built. Belzona was finally offered the contract. We ordered about \$28,000.00 worth of product and took about 3 weeks to complete this application. This job started with seams fully reinforced with mesh and 1 coat of Belzona 3111 and the second coat was sprayed and finished with. The client, a happy customer, saved on spending on a new roof worth \$78,000.00.

Seams were hand applied with mesh reinforced into the Belzona 3111. The 2nd coat was sprayed on with Graco small sprayer. The contractor used 3 people in total to complete this job.

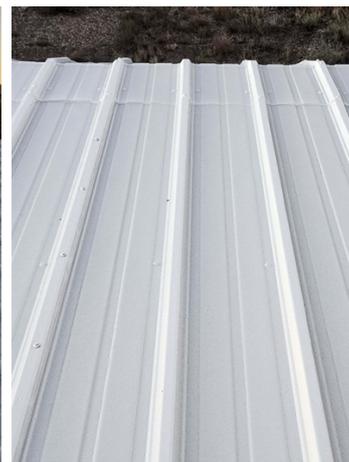
Belzona 3111 flexible membrane fully reinforced roof.
