# Belzona 3111 flexible membrane saves roof at North Dakota Mine

Industry:	Buildings & Structures	Customer Location:	Beulah, North Dakota
Application:	RPA-Roof Problem Areas	Application Date:	
Substrate:	Aluminum		
Products:	Belzona 3111 (Flexible Membrane), Belzona 3921 (GSC Surface Conditioner), Accessories, Spray Instructions

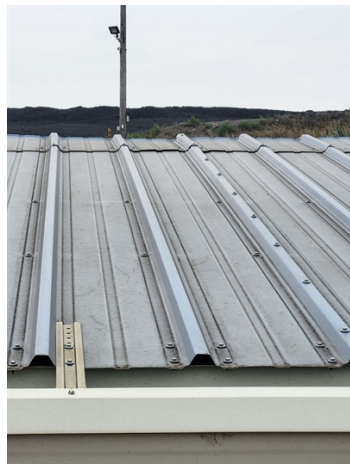
Roof area approximately 3500 sq ft had rust over 50% and very small holes and the seams were severely leaking. Building overhang out at unloading area at Mine.

Picture of roof before starting application

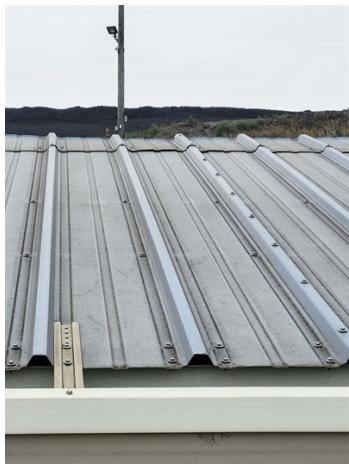
Prior to application of Belzona 3111

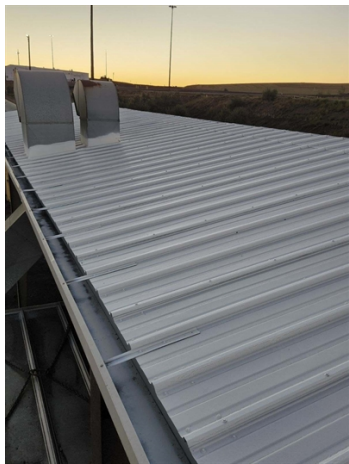
Belzona 3111 applied on 100% of roof with mesh installed on all seams fully reinforced.

Seams were hand applied with mesh reinforced into the Belzona 3111. The 2nd coat was sprayed on with Graco small sprayer. The contractor used 3 people in total to complete this job.

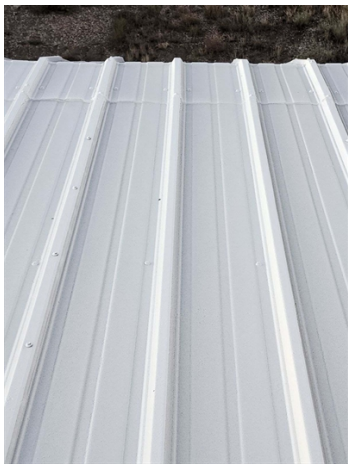
Belzona 3111 flexible membrane fully reinforced roof.

The client was looking at a new roof built. Belzona was finally offered the contract. We ordered about \$28,000.00 worth of product and took about 3 weeks to complete this application. This job started with seams fully reinforced with mesh and 1 coat of Belzona 3111 and the second coat was sprayed and finished with. The client, a happy customer, saved on spending on a new roof worth \$78,000.00.
