Belzona 5811 Immersion Grade Saves Customer Years and Millions of Dollars

Industry: Food & Drink
Application: TCC-Tanks and Chemical Containment Areas
Substrate: Carbon steel
Products: Belzona 1111 (Super Metal), Belzona 5811 (Immersion Grade), Belzona 9111 (Cleaner Degreaser)

Customer Location: Zeeland, MI, USA
Application Date: September 2018

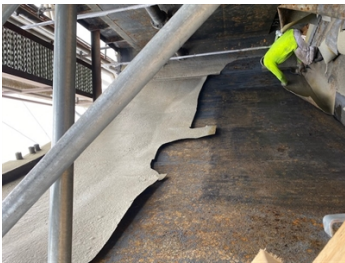
The Customer thought this clarifier tanks days were over. They submitted a permit for a new one and was told the permitting process would take five years so they started looking for a different solution. The previous coating they had installed came off in sheets and the corrosion under it had caused severe damage to the tank.

Previous coating was failing

Blast cleaned the steel which also removed the previous coating. Tack welded expanded metal where needed. Rebuilt corroded, pitted and expanded metal areas with Belzona 1111 (Super Metal). Spray applied two coats of Belzona 5811 (Immersion Grade).

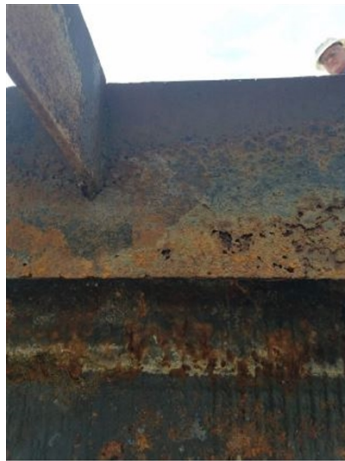
An example of the damage corrosion caused here.

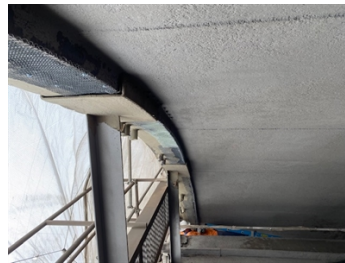
Steel was bonded to the top of the tank to provide more stability.

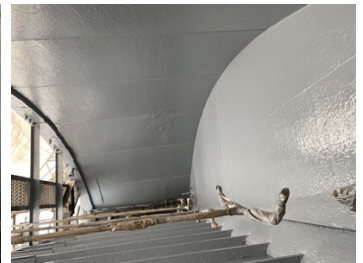
Section of the finished Belzona 5811 application.
