PUMP BELL MOUTH REBUILT AND PROTECTED WITH BELZONA

Customer Location: Power Station, Pakistan

Application: CEP-Centrifugal Pumps

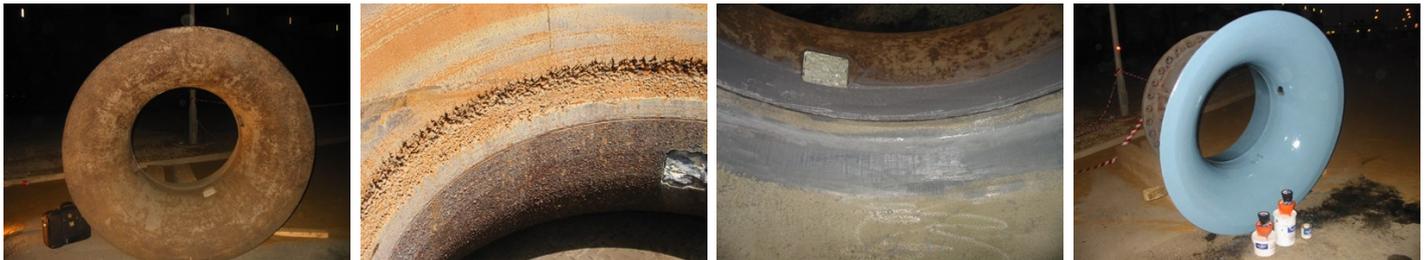
Photograph Descriptions

The pump bell mouth was badly eroded/corroded due to water quality.

* Corroded Bell Mouth , * Extent of the erosion apparent after grit blasting , * Rebuilding with Belzona® 1311 , * Completed job after applying Belzona® 1341 ,

Application was carried out in accordance with Belzona Know-How System Leaflets CEP-3 & -5.
