Revived Water Pump with Belzona

ID: 9990

Application: CEP-Centrifugal Pumps

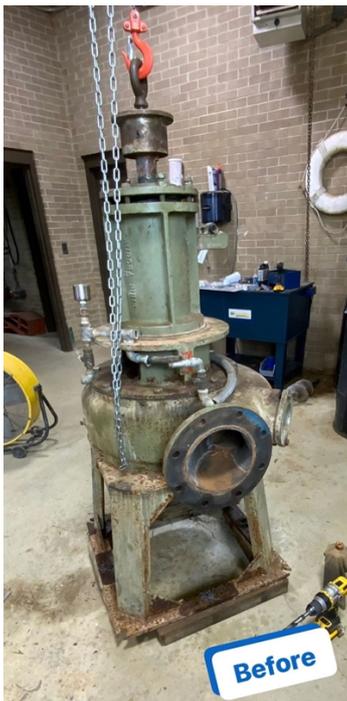
This pump is 30 plus years old and was in need of exterior restoration due to the environment it lives in.

Before Belzona restoration.

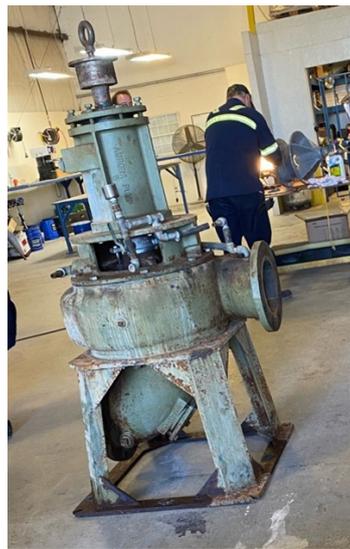
Preparing for blasting and cleaning

We blasted the surface area using a mild aggregate followed by properly cleaning the surface with an approved cleaner.

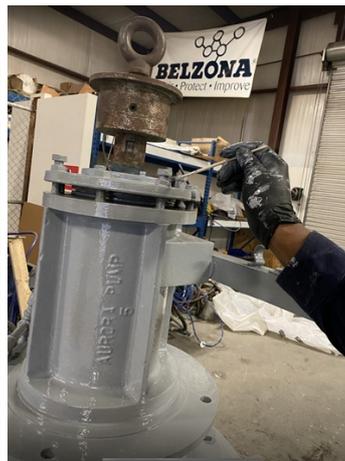
Final touch ups using Belzona 5811

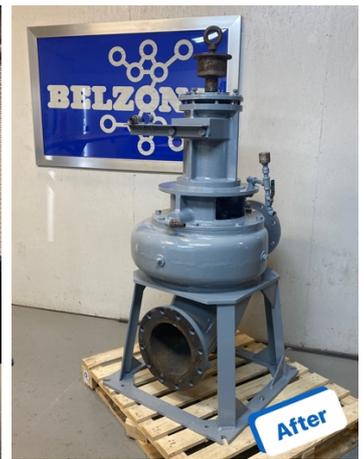
Finished results

This application saved the pump from future years of environmental damage. In order to replace this pump it would require many changes to the system costing the city thousands of dollars. We turned this pump around in three days.
