Belzona Flange Encapsulation System for Abu Dhabi Offshore Oilfields

Application: GSS-Gaskets, Seals and Shims

Application Date: May 2020

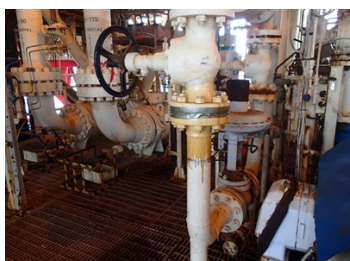
Client's maintenance crew carried out routine inspections in two oilfields off the coast of Abu Dhabi. The inspection revealed severe flanges corrosion which was a result of the aggressive operating environment.

Corroded flanges in the oilfields suffered corrosion attack and needed repair.

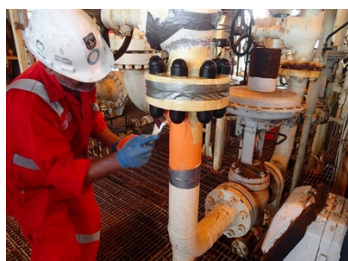
The technician applied the first coat of Belzona 3412 to protect the flange.

1. Remove the old paint from the top and bottom edges of the flange.
2. Brush away loose contaminants and degrease the surface using a rag soaked in Belzona 9111 (Cleaner Degreaser).
3. Roughen the top and bottom edges of the pipe with emery paper.

4. Apply masking tape to clearly define the coating area.
5. Apply Belzona 8411 to the flange and pipe area. Allow it to become touch dry. Belzona 8411 is required for the encapsulating membrane system in order to achieve the optimum level of corrosion protection and to allow access to bolts and flanges in the event of required maintenance.
6. Seal the gap between flange faces with bridging tape and cover bolt heads with plastic caps.
7. Mix Belzona 3412 and apply the first coat by brush at a thickness of 700–750 microns.
8. Wet out Belzona 9341 Reinforcement Tape with the mixed product to reinforce the flange and pipe edge. Allow the first coat to cure fully.
9. Once cured, apply a second coat of Belzona 3412 by brush at a thickness of 700–750 microns. Belzona 3412 is available in two colours and Belzona recommends different color for each coat.

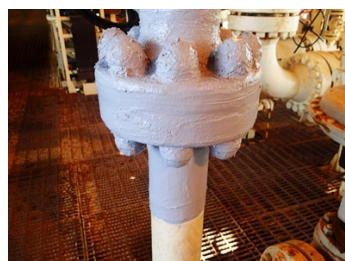
The second coat of Belzona 3412 was applied on the flanges and bolts.

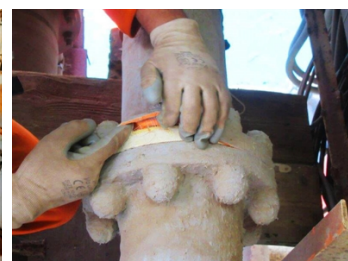
Six months after the application, the membrane was cut for an inspection and it was found that the flanges were in excellent condition.

Six months after the application, the Distributor has carried out an inspection and confirmed that the condition of the flanges was found to be excellent.
