Belzona repairs leaks in cooling towers and extends their lifespan

ID: 9995

Application: HEX-Heat Exchangers

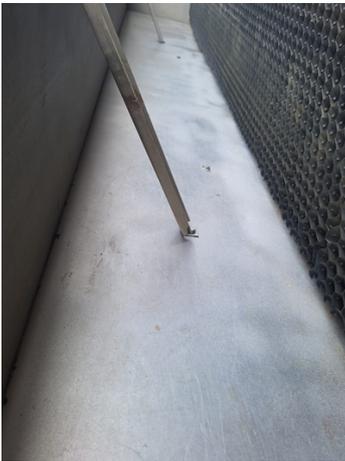
Surface preparation prior to Belzona systems being applied

1. Surface preparation: The cooling tower base and joints were cleaned and blasted to remove failed sealants, dirt, and contaminants.
2. Conditioning: Belzona 2911 (Elastomer QD Conditioner) was applied to ensure maximum adhesion.
3. Sealing: Joints were rebuilt and sealed using Belzona 2211 (MP Hi-Build Elastomer) and Belzona 2221 (MP Fluid Elastomer) for flexibility and resilience.
4. Protection: The base was over-coated with Belzona 5811 (Immersion Grade) to provide chemical and corrosion resistance in continuous immersion service.

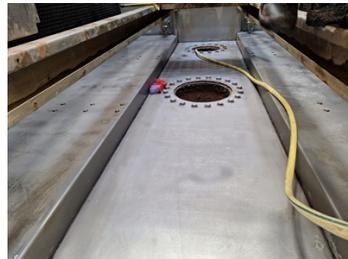
All the existing silicon's removed

All the joints are sealed with Belzona elastomer 2211 (MP Hi-Build Elastomer) and Belzona 2221 (MP Fluid Elastomer)

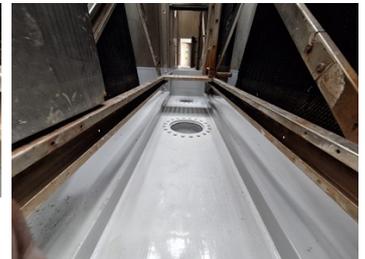
Application of Belzona 5811 (Immersion Grade) was carried out to enhance the protection of the cooling tower base
