# Methanol Column Skirt Repair

ID: 9997

Application: TCC-Tanks and Chemical Containment Areas

Substrate: Carbon steel

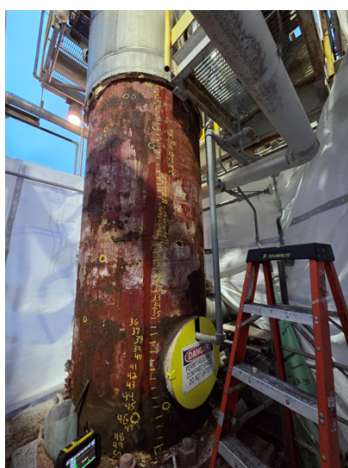
The bottom 30–35 inches showed extensive damage, including deeper pitting and metal loss.

Heavy pitting at the bottom of the skirt. Before the application of Belzona.

During scheduled inspection, corrosion and pitting were discovered beneath the fireproofing at the base of a methanol column. The lower 30–35 inches of the skirt showed significant degradation, with deeper pitting and signs of wall thinning. The remaining upper skirt areas were moderately affected.

Deep pitted areas were rebuilt with Belzona 1511.  
Hand-applied and profiled flush with parent metal.

Applied using Belzona 1984 resin to bottom 30–35 inches. Applied in multiple wraps with reinforcing sheet for hoop strength.

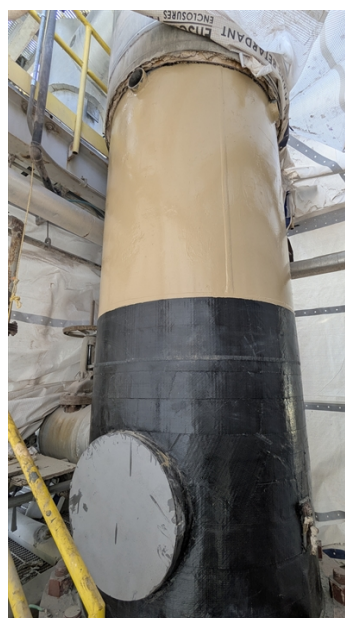
We have successfully revitalized the structure, restoring its strength and beauty after the application of Belzona.

Remaining skirt area coated in two layers of 5811 for immersion-grade corrosion protection.

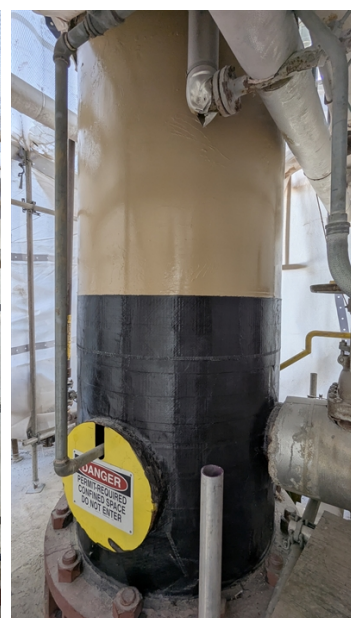
Another angle of completed repair
