Belzona Repairs & Protects Dredge Apparatus Piping

ID: 9998

Industry: Marine
Application: VPF-Valves, Pipes and Fittings
Substrate: Carbon steel
Products: Belzona 1311 (Ceramic R-Metal), Belzona 1814, Accessories

Customer Location: Morgan City, LA
Application Date: August 2025

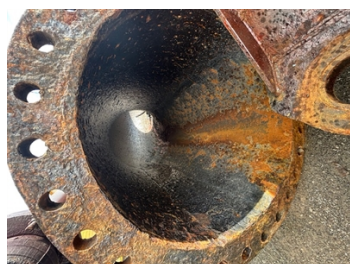
Customer was taking apart dredge apparatus after being in service continuously for over 6 years. Piping was heavily eroded with multiple through-wall holes (not pictured). Customer needed to get dredge apparatus back to work on contract within 1 month. Customer chose Belzona for a repair and coat system rather than spending several hundred thousand on new equipment.

Dredge pipe after being taken down from apparatus.

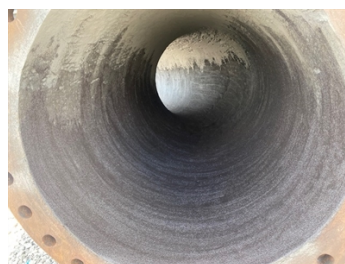
Dredge pipe after bottom half coated with Belzona 1814 working outward from center. Pipe was flipped over to complete job while making for easier application.

Dredge pipes were cleaned and blasted to SSPC-SP10 for surface prep. The through-wall holes were rebuilt with Belzona 1311/9341 and then entire pipe internals were coated with Belzona 1814.

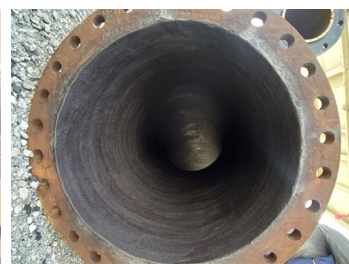
Dredge completely coated with Belzona 1814.
