Internal Repair and Protection of two Kort Nozzles Using Belzona 1311 and Belzona 1341

ID: 9999

Industry: *Marine*
Application: *SOS-Ships and Offshore Structures*

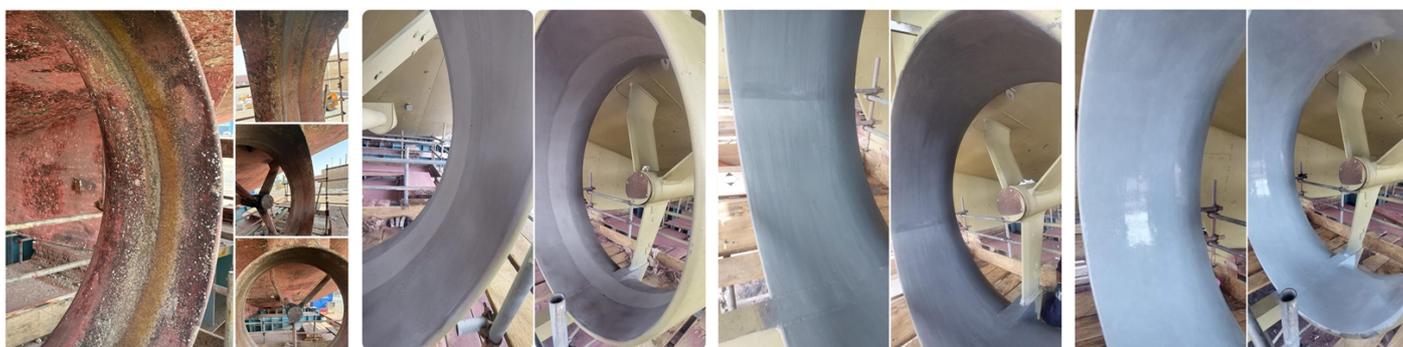
Kort nozzles condition suffers severe metal loss and require Belzona application

Surface preparation prior to the repair by Belzona solution

Surface rebuilding by Belzona 1311 (Ceramic R-Metal)

Kort nozzles are further protected by Belzona 1341 (Supermetalglide) coating.

Surface preparation was carried out to SSPC-SP10 (Near-White Metal Blast) standards, achieving a 3-mil (75 µm) surface profile through precision grit blasting. The substrate was then thoroughly cleaned and degreased using residue-free solvents to ensure maximum adhesion.

Once the surface was properly prepared, Belzona 1311 (Ceramic R Metal) was mixed and applied to restore and smooth out the pitted and eroded areas. For long-term erosion and corrosion protection, a two-coat system of Belzona 1341 (Supermetalglide) was applied — with the second coat applied within the recommended overcoat window to ensure optimal bonding and performance.
