BELZONA SEALS SF6 LEAK IN HYDROELECTRIC POWER STATION

Customer Location: Hydroelectric power generating station
in British Columbia, Canada

Application: GSS-Gaskets, Seals and Shims

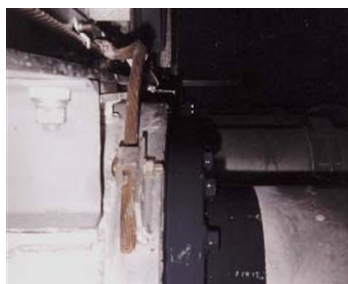
The SF6 dielectric gaseous insulator was leaking from the flange.

- * Belzona® 2211 (MP Hi-Build Elastomer) was injected between flanges to fill the gap. ,
- * Completed application. ,
- * Various leaking flanges were sealed ,

Flanges of SF6 (sulfur hexafluoride) buss bars.

The application was carried out in accordance with Belzona Know-How Leaflet GSS-4.

Since the customer realized significant cost savings, several leaks were repaired. Four and one-half years later the original repair is still holding.
