# BELZONA KEEPS BEET SLICER RUNNING

Industry: Sugar  
Application: MPT-Mechanical Power Transmission

Customer Location: Sugar Beet Mill in North Dakota, U.S.A.  
Application Date: 1983

Bearing failure damaged beet slicer shaft

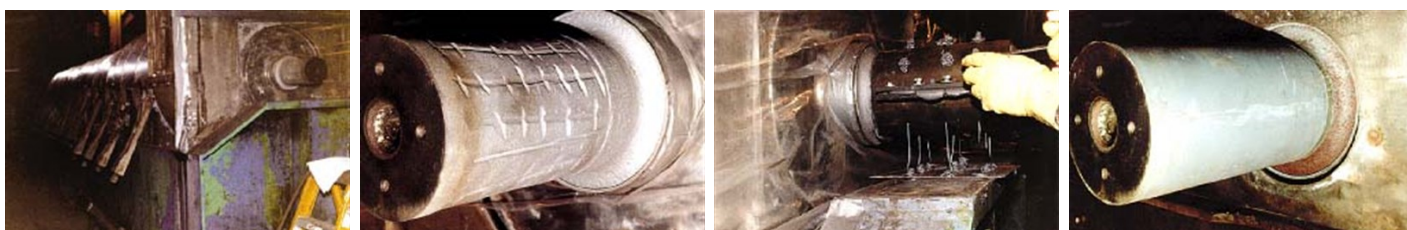
- \* View of damaged shaft . ,
- \* Application of Belzona® 1111 (Super Metal). ,
- \* Use of a former to rebuild shaft. ,
- \* Completely rebuilt shaft. ,

The application was carried out in accordance with Belzona Know-How Leaflet MPT-2.

Repair allowed customer to save time and money by avoiding disassembly of machinery.
