# BELZONA REFORMS MAIN ENGINE LINER LANDS AND CORRODED COOLING WATER PASSAGES

Industry: *Marine*  
Application: *ENC-Engines and Casings*  
Substrate: *Cast iron*  
Products: *\* Belzona® 1111 (Super Metal) ,*

Customer Location: *Ship Dockyard, France*  
Application Date: *1998*

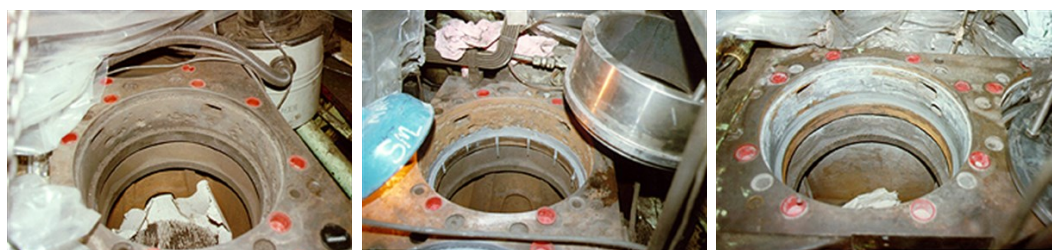
## Photograph Descriptions

*Corrosion in water cooled top land area of engine block.*

- \* After grit blasting the degree of corrosion clearly evident ,
- \* Lower land reformed ,
- \* Cylinder rebuilt awaiting final finishing ,

Application was carried out in accordance with Belzona System Leaflet ENC-4, using formers to reconstruct the two cylinder liner lands in each cylinder.

Belzona was used because there was no other suitable solution. Machining would have weakened the cylinder block.
