Historical Railway carriage is revamped with a waterproof membrane

ID: 10003

Industry: *Transport*
Application: *RPA-Roof Problem Areas*
Substrate: *Other*
Products: *Belzona 3111 (Flexible Membrane)*

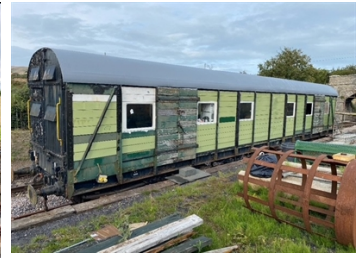
Completed application, restoring integrity to roof

Once the roof has been cleared of all debris and prepared to minimum surface profile, Belzona 3921 as a general surface conditioner. Then, two coats of Belzona 3111 was applied to a reinforcement sheet to cover the train roof.
