Repairs to corroded internal sealing faces at a paper mill

Application: CEP-Centrifugal Pumps

Substrate: Cast Iron

Products: Belzona 1161 (Super UW-Metal), Belzona 1311 (Ceramic R-Metal)

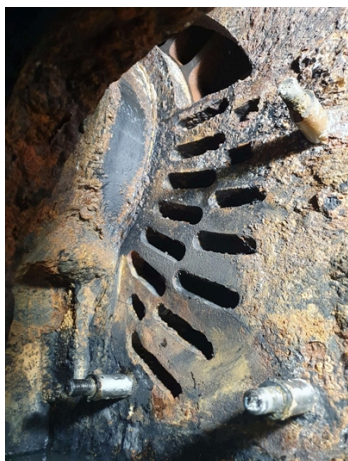
The customer had severely corroded sealing faces. Due to difficult with access, grit blasting was not an option and there was only a very short window of time to carry out any repairs. Customer required a long lasting permanent solution to the issue.

Heavily corroded sealing face.

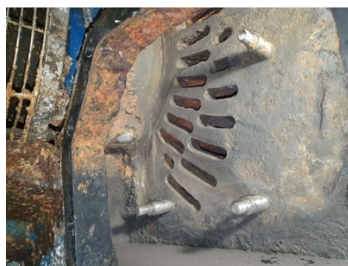
Surface preparation carried out and area degreased

The area's were degreased and then wetted out using Belzona 1161 Super UW-Metal (Surface tolerant product) and allowed to cure.

The surface was then lightly abraded and then wetted out with Belzona 1311 Ceramic R-Metal.

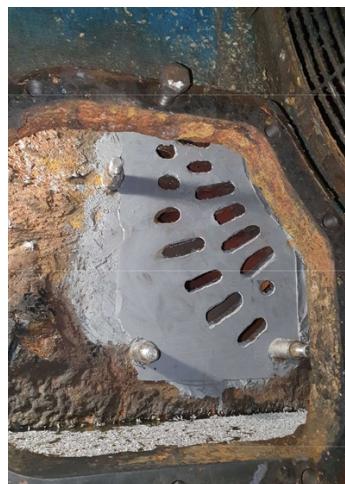
Former plate applied to defective area and Belzona 1161 allowed to cure

Belzona 1311 was then applied to the former plates which had been coated with Belzona 9411 Release Agent, and then put up against the worn faces and allowed to cure.

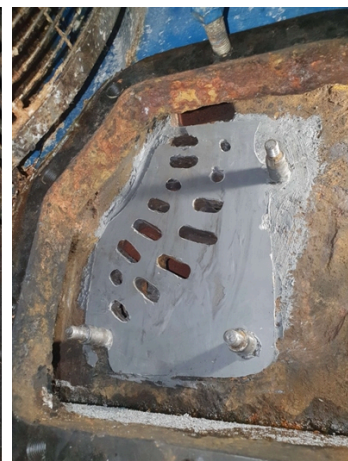
Sealing face formed at drive and non-drive end.
