# Slurry Line Leak Repair – Cold-Applied Composite Solution at Cement Plant

ID: 10007

Application: VPF-Valves, Pipes and Fittings

Substrate: Carbon steel

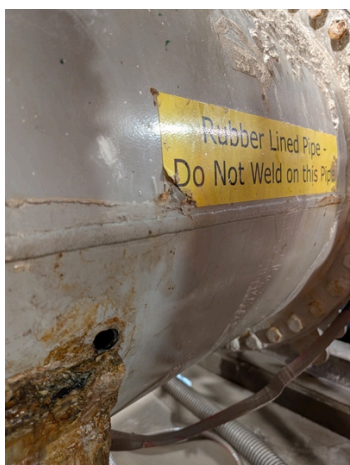
A rubber-lined slurry pipe inside a cement plant has developed an approx 1-inch diameter hole that has penetrated through the wall, resulting in an active leak of abrasive slurry.

A hole in a pipe before the application.

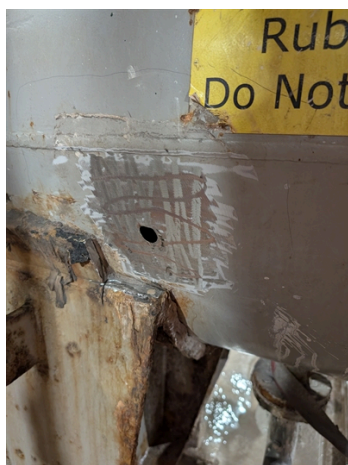
The surface has been prepared for the application

Leaking pipe surface roughened with the power tool to SSPC-SP10 standard, Surface cleaned and roughened to ensure high adhesion

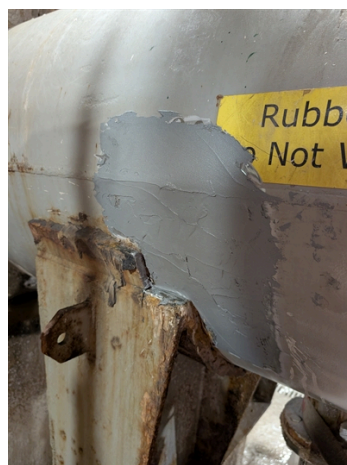
Rebuild with Belzona 1161 with 9341 mesh

Belzona 1161 applied over leak zone, 9341 mesh embedded within 1161 to arrest leak and rebuild wall thickness. Cured and profiled as a foundation for the wrap system

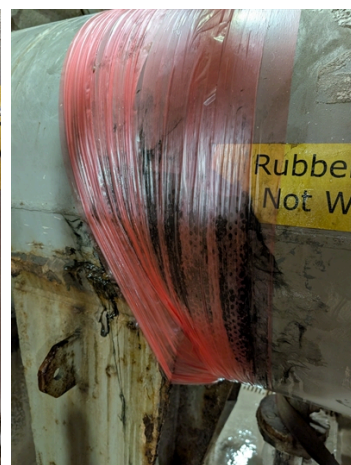
Strengthening the repair with Super Wrap II with Belzona 1984

SuperWrap II system applied using 1984 resin with 9381 carbon fibre wrap and 9382 consolidation film.  
Applied in multiple layers to meet the thickness and strength required.
