# Belzona Protects Ball Mill Braces

ID: 10009

Application: SHM-Solids Handling Machinery

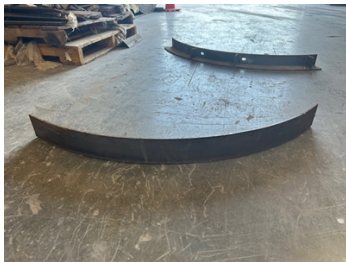
Customer was having high erosion on the braces supporting a ball mill handling Barite. Due to the high velocity and operating temperature of 300F, the Barite powder in the air was degrading the braces to no use within 2-3 months.

New upper and lower braces at customer location.

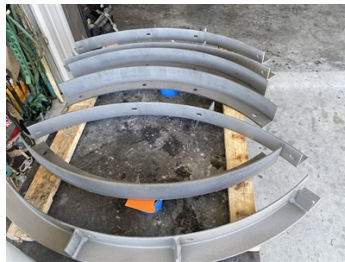
Braces blasted and prepped for application at Belzona/AAS location.

Braces were blasted and cleaned with Belzona 9111. Braces were then twice coated with Belzona 1331 by hand.

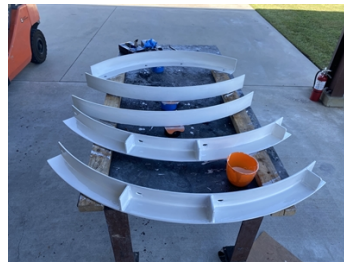
First coat of Belzona 1331 applied.

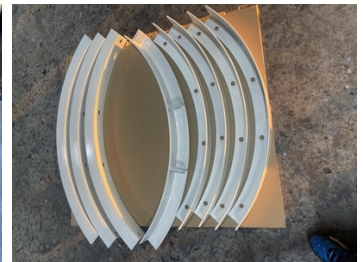
Second coat of Belzona 1331 applied and final product.
