End Suction Potable Water Pump Refurbishment

ID: 10012

Application: CEP-Centrifugal Pumps

Customer Location: Khurais Saudi Arabia

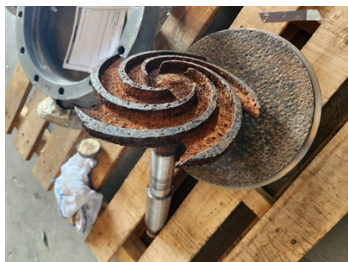
An impellor suffered corrosion from prolonged exposure to water

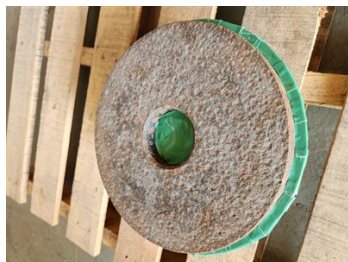
Eroded pump component required immediate solution
