End Suction Potable Water Pump Refurbishment

ID: 10012

Customer Location: Khurais Saudi Arabia

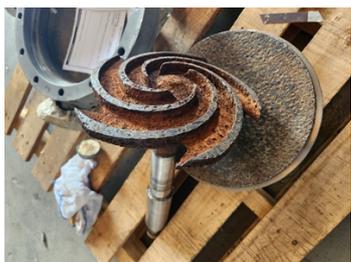
An impellor suffered corrosion from prolonged exposure to water

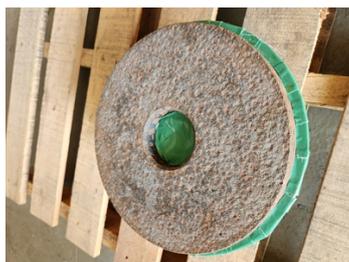
Eroded pump component required immediate solution
