Particulate Filter Vessels Internal Coating

ID: 10013

Industry: Other
Application: TCC-Tanks and Chemical Containment Areas
Substrate: Carbon steel
Products: Belzona 1391T, Belzona 1511 (Super HT-Metal)

Customer Location: Saudi Arabia
Application Date: October 2024

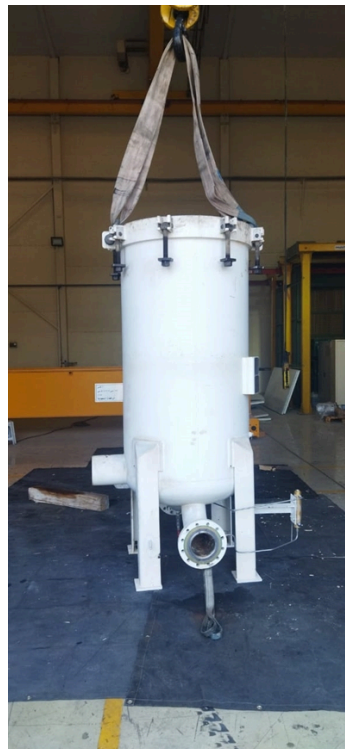
Existing lining failed and started to show sign of corrosion

Old lining was removed before the repair

Before the new coating was applied, all loose materials were removed. The coating was subsequently applied with basic tools, a brush and plastic applicator, to install a protective barrier for the internal vessel lining.

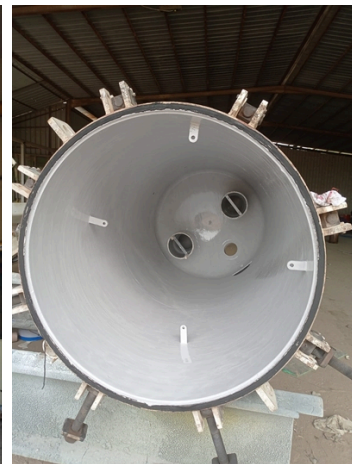
Coating during process

Completed application
