Belzona protects concrete & drainage areas

ID: 10017

Industry: Power
Application: FPA-Floor Problem Areas
Substrate: Concrete
Products: Belzona 5811 (Immersion Grade), Belzona 5831 (ST-Barrier), Belzona 9111 (Cleaner Degreaser)

Customer Location: Orapa, Botswana
Application Date: October 2025

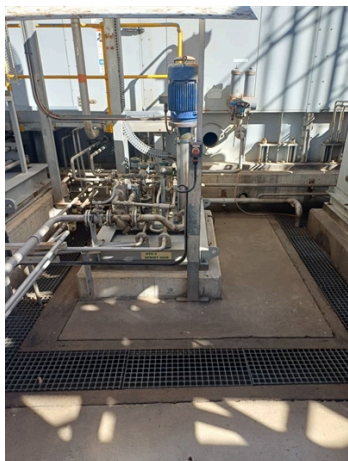
Areas were contaminated by accidental oil and diesel spillages causing environmental complications.

Contaminated areas before cleaning commences.

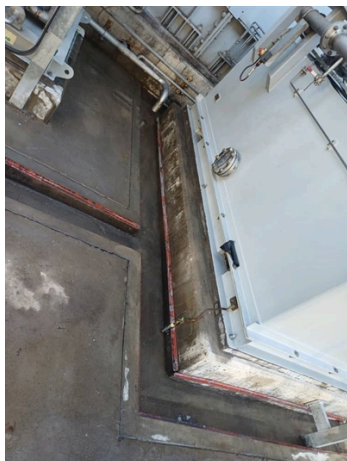
Cleaning in progress. Belzona 9111 degreaser, concrete cleaner & a water based detergent were used and then high pressure washed with clean water.

Contaminated areas were degreased with Belzona 9111 & concrete cleaner. They were then cleaned with a water based detergent and pressure washed with clean water. Belzona 5831 was used as a first coat followed by a top coat of Belzona 5811.

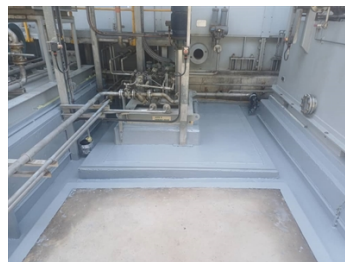
Coating in progress.
