# Condenser Cave In

ID: 10021

Industry:	Power	Customer Location:	Louisiana
Application:	HEX-Heat Exchangers	Application Date:	October 2025
Substrate:	Carbon steel		
Products:	Belzona 1121 (Super XL-Metal),Belzona 5821

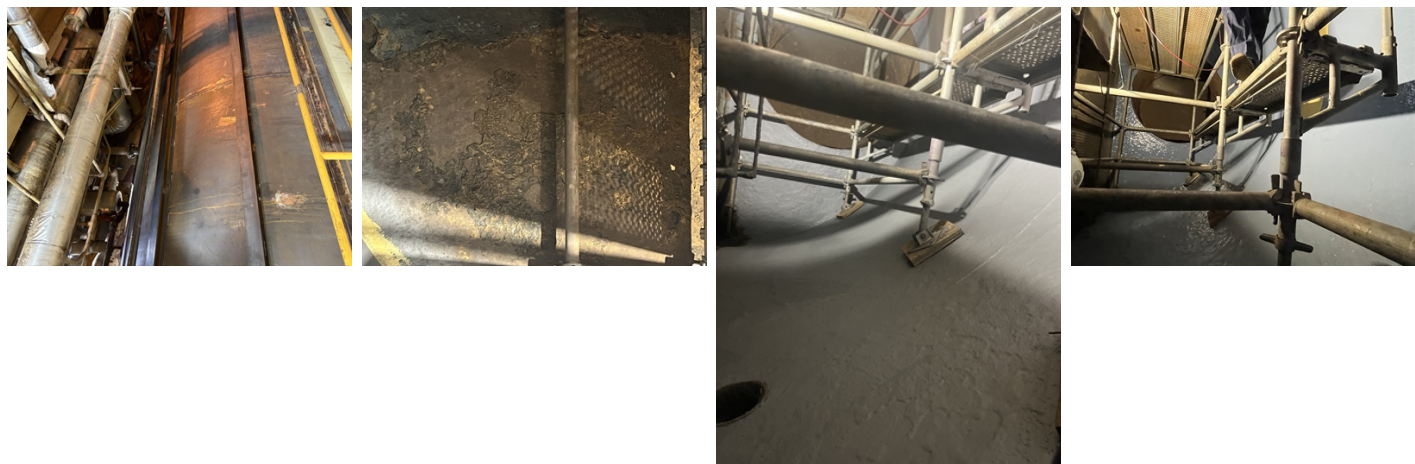
Side wall had caved in and leaking. Plant replaced wall with new metal. We then applied Belzona 1121 for rebuild and coated complete internals with Belzona 5821.

New metal work installed on condenser	Existing internal metal before preparing for coating	Substrate after applying Belzona 1121	Substrate after applying Belzona 5821
---------------------------------------	--	---------------------------------------	---------------------------------------

Grit blasted with Black beauty to SP-10, wiped down with MEK, applied 120 kg’s of Belzona 1121 and two coats of Belzona 5821
