# Belzona Solution for Tank Leak Repair by Plate Bonding Method

ID: 10023

Application: TCC-Tanks and Chemical Containment Areas

Substrate: Carbon steel

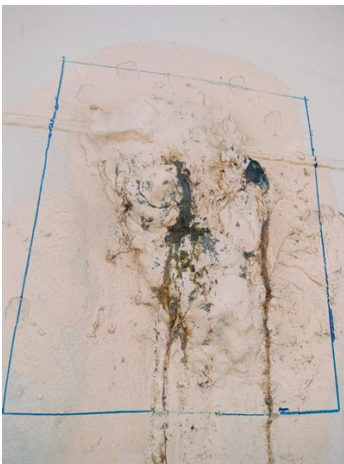
A leak in the wall of the customer's fire water tank created a hole and disrupted operations.

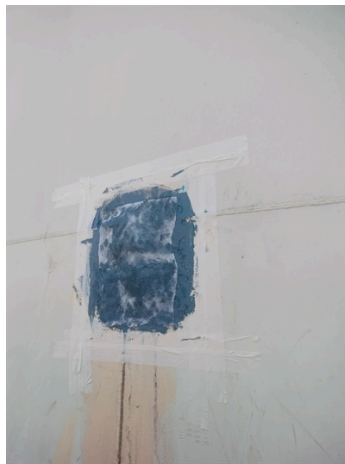
Following cleaning, the substrate was grit-blasted, and Belzona 9611 (ES-Metal) was applied to effectively seal the leak.

1. After thorough cleaning, the surface plate was grit-blasted using power tools to achieve the required profile and prepare the substrate.

2. Belzona 9611 (ES-Metal) was applied initially to seal the leak, followed by Belzona 1161 to reinforce the material prior to plate bonding.

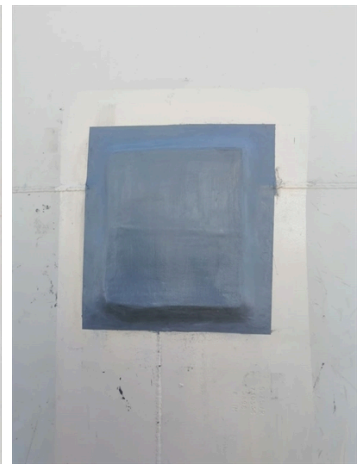
Belzona 1161 (Super UW-Metal) was applied via the plate bonding method.

3. A subsequent layer of Belzona 1161 (Super UW-Metal) was applied to further rebuild the surface and achieve a smooth, finished profile.
