# Wastewater Tank Lining - Spot Repairs

ID: 10024

**Industry:** Chemical & Petrochemical  
**Application:** TCC-Tanks and Chemical Containment Areas  
**Substrate:** Stainless-steel  
**Products:** Belzona 1121 (Super XL-Metal), Belzona 5892

**Customer Location:** Greater Houston, TX  
**Application Date:** October 2025

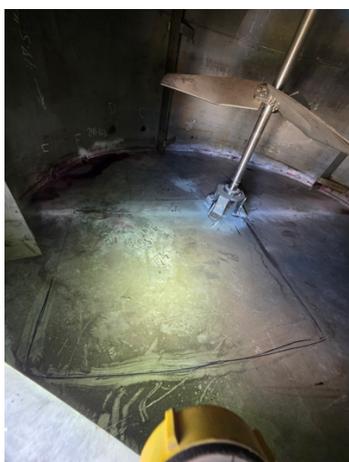
Customer had internal defects causing pitting and thin wall metal in two isolated areas on the floor of a wastewater tank. They weren't able to make weld repairs in this area because it was not possible and would not stop the corrosion. They were looking for a quick repair method because they had to use a rental tank to divert wastewater too, while this was out of service for repair.

Before images, with markings to identify application area

After safety permitting was complete, we accessed the confined space. We marked and taped off the two defect areas that were on the floor. One was roughly 4'x4' and one was 4'x2'. Next we used emerald grit to abrasive blast the application area to achieve a rough dry clean 3mil minimum anchor profile (SSPC-SP10). We blew a dehumidifier into the asset during application to keep atmospheric conditions under control. Battery powered LED's were used to provide light inside the tank. Belzona 1121 was used to pit fill as needed. Then a two coat system of Belzona 5892 was applied. Inspection was completed per the IFU, to touch up any holidays as needed. Product was allowed to cure before return to service.

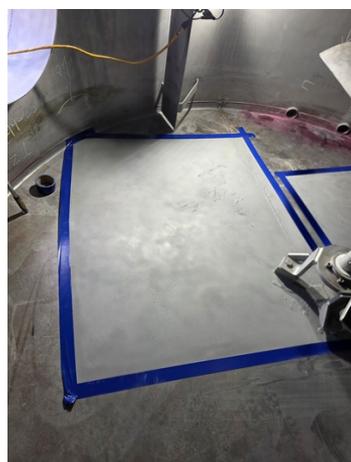
Abrasive Blast prep (SSPC-SP10)

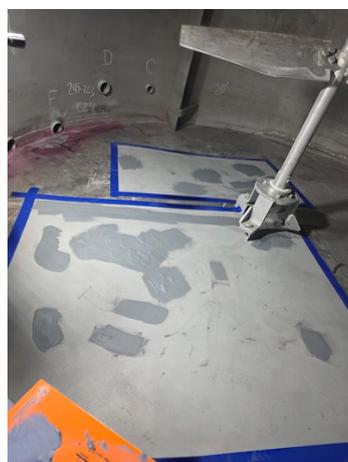
Belzona 1121 to pit fill

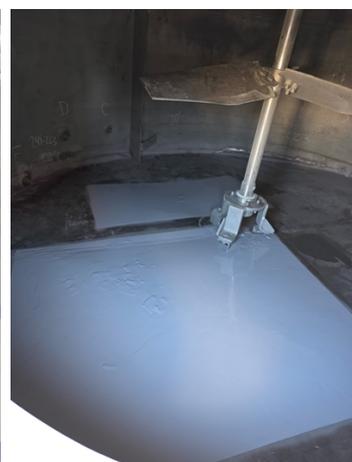
Belzona 5892 Final Coating
