# Wastewater Tank Lining - Spot Repairs

ID: 10024

**Industry:** Chemical & Petrochemical  
**Application:** TCC-Tanks and Chemical Containment Areas  
**Substrate:** Stainless-steel  
**Products:** Belzona 1121 (Super XL-Metal), Belzona 5892

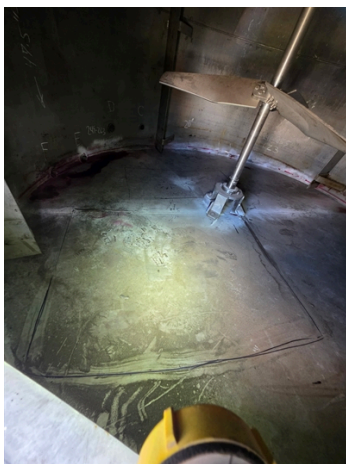
Customer had internal defects causing pitting and thin wall metal in two isolated areas on the floor of a wastewater tank. They weren't able to make weld repairs in this area because it was not possible and would not stop the corrosion. They were looking for a quick repair method because they had to use a rental tank to divert wastewater too, while this was out of service for repair.

Before images, with markings to identify application area

After safety permitting was complete, we accessed the confined space. We marked and taped off the two defect areas that were on the floor. One was roughly 4'x4' and one was 4'x2'. Next we used emerald grit to abrasive blast the application area to achieve a rough dry clean 3mil minimum anchor profile (SSPC-SP10). We blew a dehumidifier into the asset during application to keep atmospheric conditions under control. Battery powered LED's were used to provide light inside the tank. Belzona 1121 was used to pit fill as needed. Then a two coat system of Belzona 5892 was applied. Inspection was completed per the IFU, to touch up any holidays as needed. Product was allowed to cure before return to service.

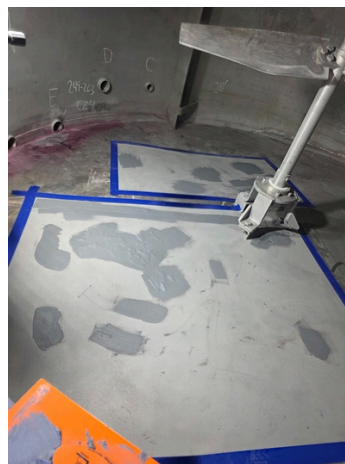
Belzona 1121 to pit fill

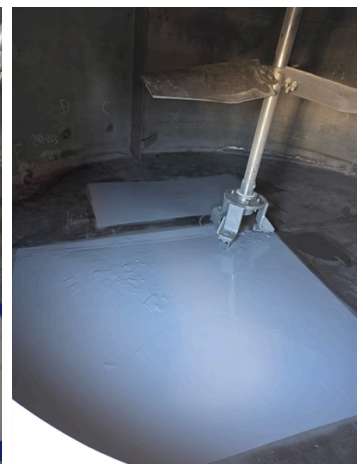
Belzona 5892 Final Coating
