External Composite Wrap on Tank Roof Nozzles

ID: 10025

Industry: Chemical & Petrochemical
Application: TCC-Tanks and Chemical Containment Areas

Customer Location: Greater Houston, TX
Application Date: September 2025

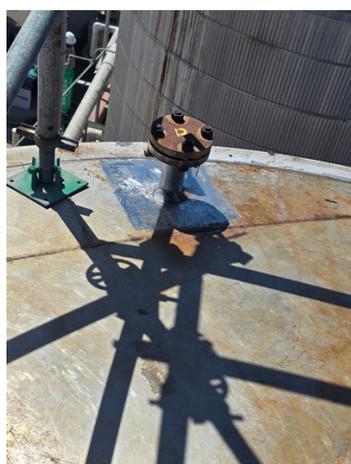
Belzona 9611 applied to seal the vapors, and a sparkless grinder used for surface prep (SSPC-SP11)

1. Belzona 9611 was applied to plug the defect
2. Sparkless grinders were used to create an anchor profile (SSPC-SP11)
3. Belzona 4181 mortar was applied around the weld seam to create a chamfer / smooth transition for the composite wrap.
4. Belzona 4181 resin and 9371 fiberglass were used to composite wrap the nozzle, 2 wrap/4 layer system extending 8" each direction from defect.
5. Belzona 5721 was applied as the UV resistance top coating.

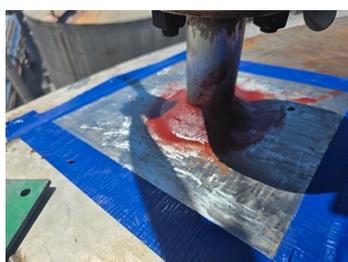
Belzona 4181 mortar applied around the neck to create a smooth chamfer for the composite wrap

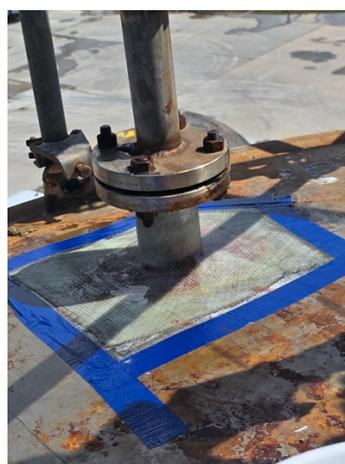
Belzona 4181 resin wet out into Belzona 9371 fiberglass reinforcement mesh to composite wrap the nozzle

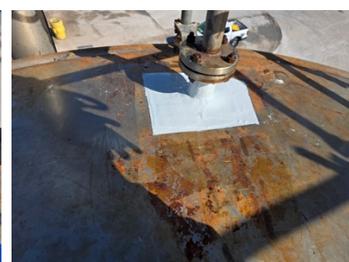
Final image with Belzona 5721 top coat applied
