External Composite Wrap on Tank Roof Nozzles

ID: 10025

Industry: Chemical & Petrochemical

Application: TCC-Tanks and Chemical Containment Areas

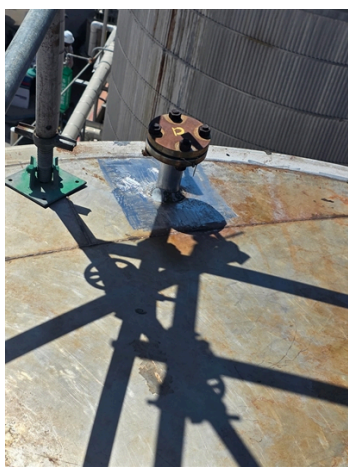
Customer had two nozzles on the roof of a stainless steel tank that were leaking vapors through the weld. This imposed a major safety issue with the chemical vapors leaking into the air, along with downtime costs to get this tank back in operation as soon as possible.

Belzona 9611 applied to seal the vapors, and a sparkless grinder used for surface prep (SSPC-SP11)

1. Belzona 9611 was applied to plug the defect
2. Sparkless grinders were used to create an anchor profile (SSPC-SP11)
3. Belzona 4181 mortar was applied around the weld seam to create a chamfer / smooth transition for the composite wrap.
4. Belzona 4181 resin and 9371 fiberglass were used to composite wrap the nozzle, 2 wrap/4 layer system extending 8" each direction from defect.
5. Belzona 5721 was applied as the UV resistance top coating.

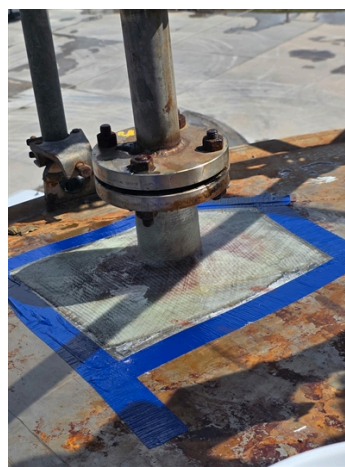
Belzona 4181 resin wet out into Belzona 9371 fiberglass reinforcement mesh to composite wrap the nozzle

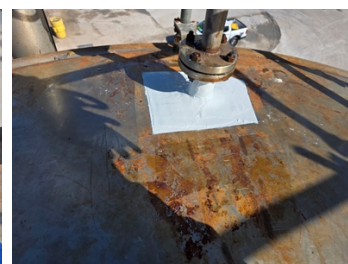
Final image with Belzona 5721 top coat applied
