End suction pump casing repaired with Belzona

ID: 10029

Application: CEP-Centrifugal Pumps

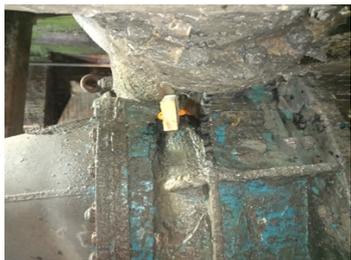
A pump used for moving waste water had eroded to the point where it had begun leaking. A temporary repair had been attempted but now a more permeant fix was required. The pump cutwater was experiencing the worst erosion.

Temporary leak fix

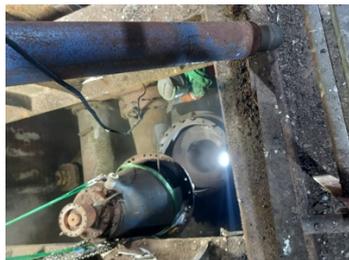
Casing accessed during shutdown & grit blasting underway

The area was first grit blasted to SA2.5 & 75 microns. A holed area was rebuilt using Belzona 1311 internally & a bonded metal doubler plate on the external. Two coats of Belzona 1321 were then applied for future erosion/corrosion protection.

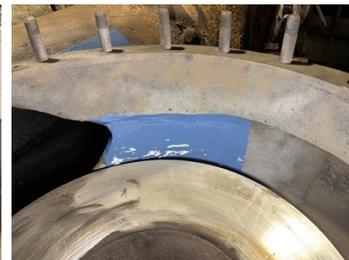
2nd coat of Belzona 1321 Ceramic S Metal applied
