# End suction pump casing repaired with Belzona

ID: 10029

Application: CEP-Centrifugal Pumps

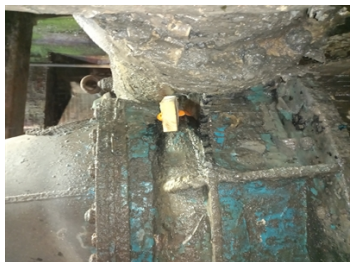
A pump used for moving waste water had eroded to the point where it had begun leaking. A temporary repair had been attempted but now a more permeant fix was required. The pump cutwater was experiencing the worst erosion.

Temporary leak fix

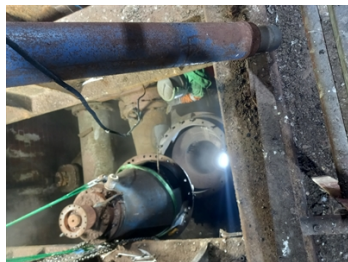
Casing accessed during shutdown & grit blasting underway

The area was first grit blasted to SA2.5 & 75 microns. A holed area was rebuilt using Belzona 1311 internally & a bonded metal doubler plate on the external. Two coats of Belzona 1321 were then applied for future erosion/corrosion protection.

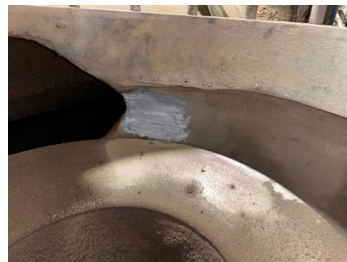
Belzona 1311 Ceramic R Metal applied internally to rebuild the hole at the cutwater

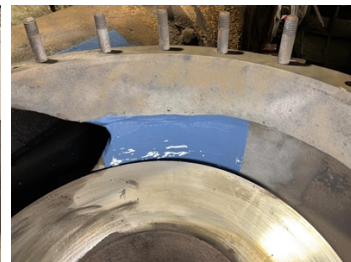
2nd coat of Belzona 1321 Ceramic S Metal applied
