# Pipe spool repaired with Belzona SuperWrap II

ID: 10030

Industry: Water / Wastewater  
Application: VPF-Valves, Pipes and Fittings  
Substrate: Carbon steel  
Products: Belzona 1212, Belzona SuperWrap II

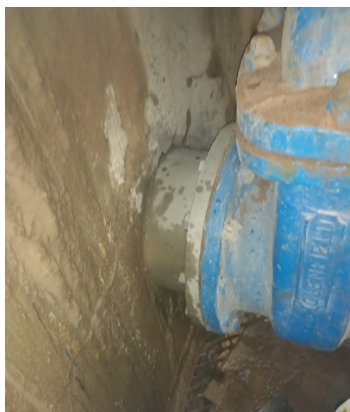
A large crack had formed in a pipe spool. This pipe was located deep within a reservoir sump & was impossible to remove without major structural works. A repair had to be put in place in-situ to prevent further leakage & to reinforce the area.

The leaking spool was built into the concrete sump wall - this went directly out to the reservoir.

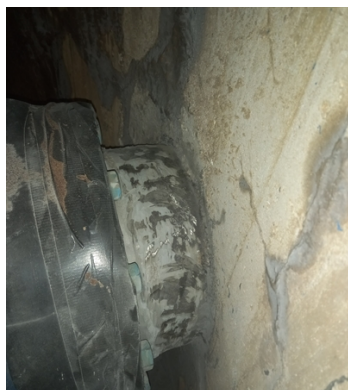
Surface preparation & application of Belzona 1212

The area was first grit blasted to SA2.5 & 75 microns. Belzona 1212 was then applied to any cracked areas. Four layers of Belzona SuperWrap II were then applied & consolidated using Belzona 9382.

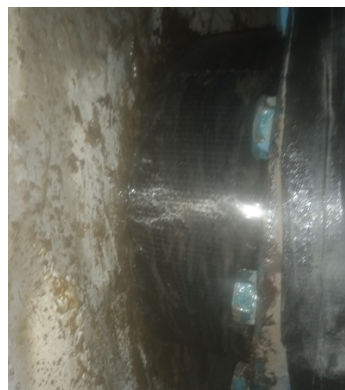
Layers of Belzona SuperWrap II applied

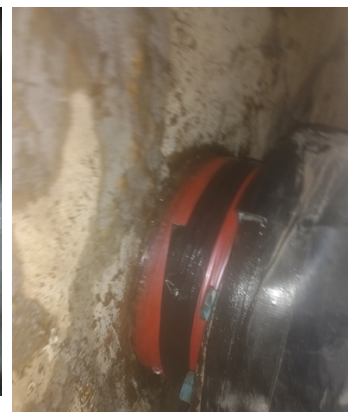
Repair consolidated

Belzona 1212 carried the WRAS approval required for water contact. Using the SuperWrap II system imparted additional strength to the pipe to reduce the chances of further cracking.
